Devil's Gate Monitoring Log

Devil's Gate Reservoir Restoration Project - 2018-047.009

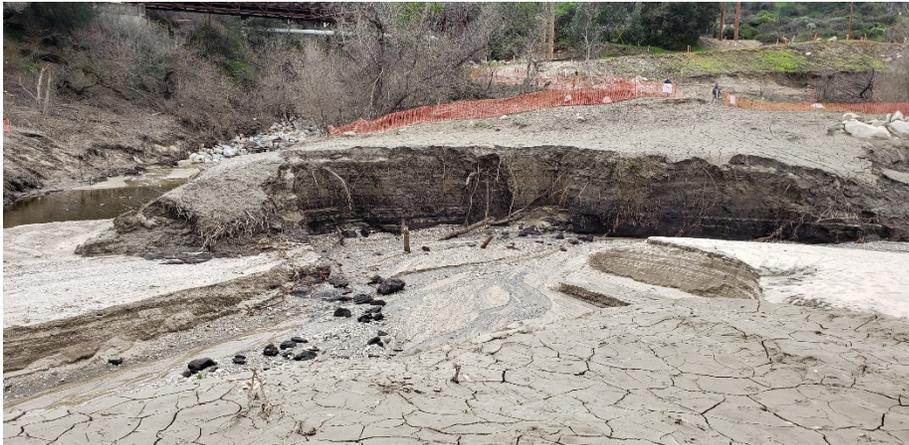
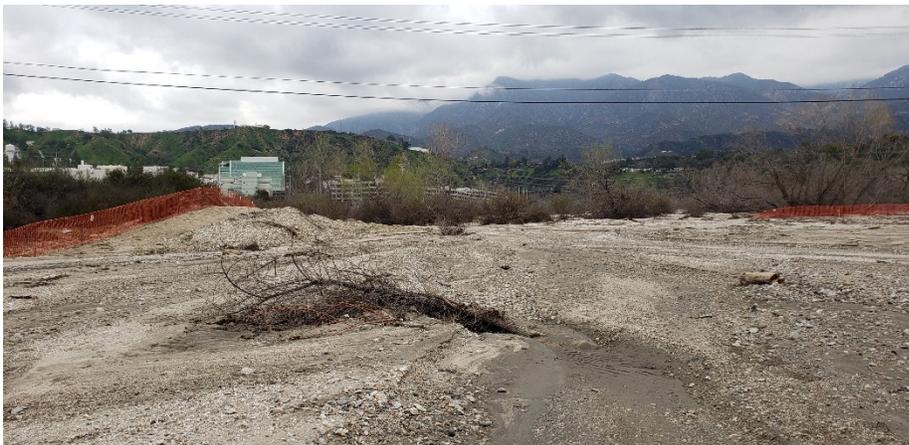
Lots of debris, including trees, washed into site likely from storm over weekend. (Pictures of east side at south and north end).

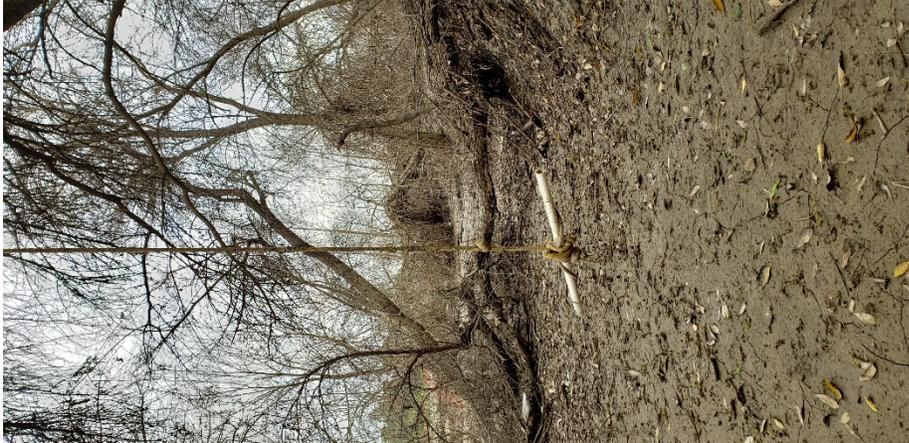
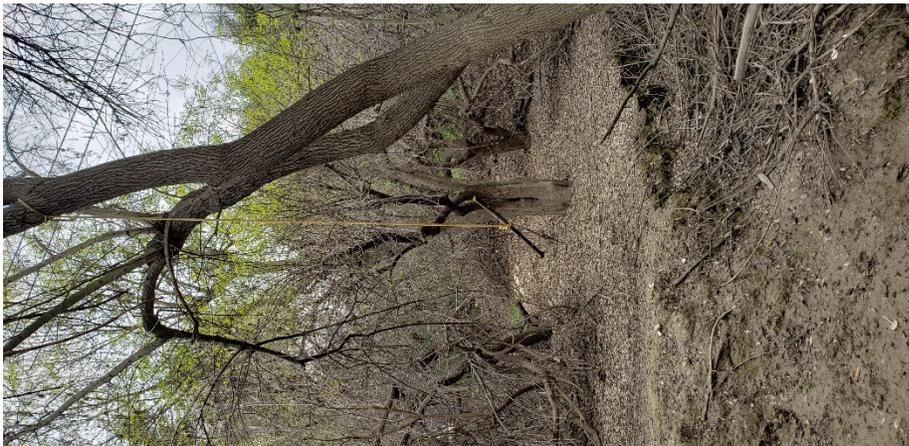
Observed 2 swings in restoration area along west side and near Berkshire creek. Also observed recreationists walking on project site.

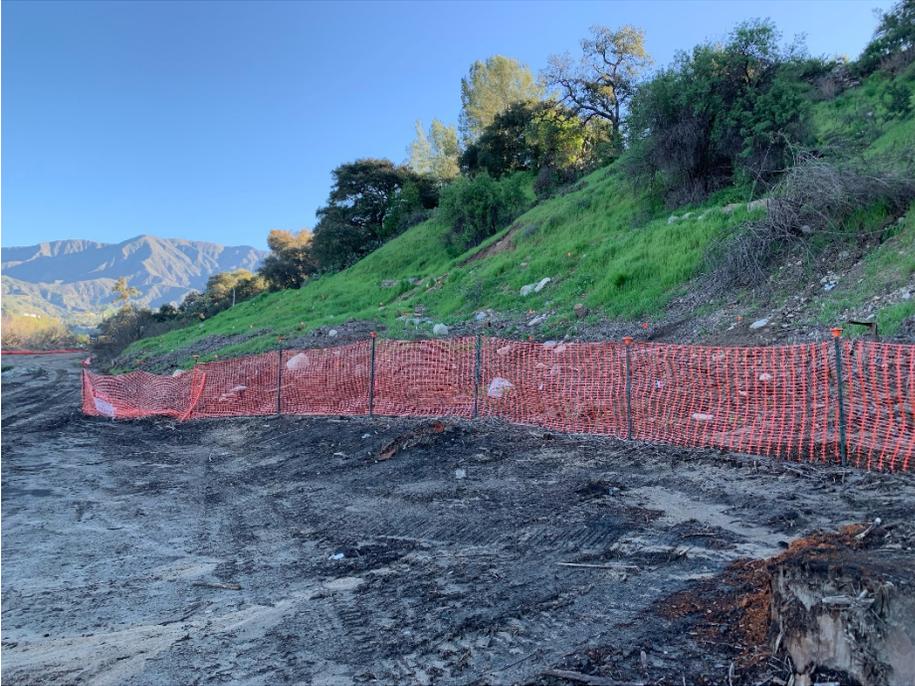
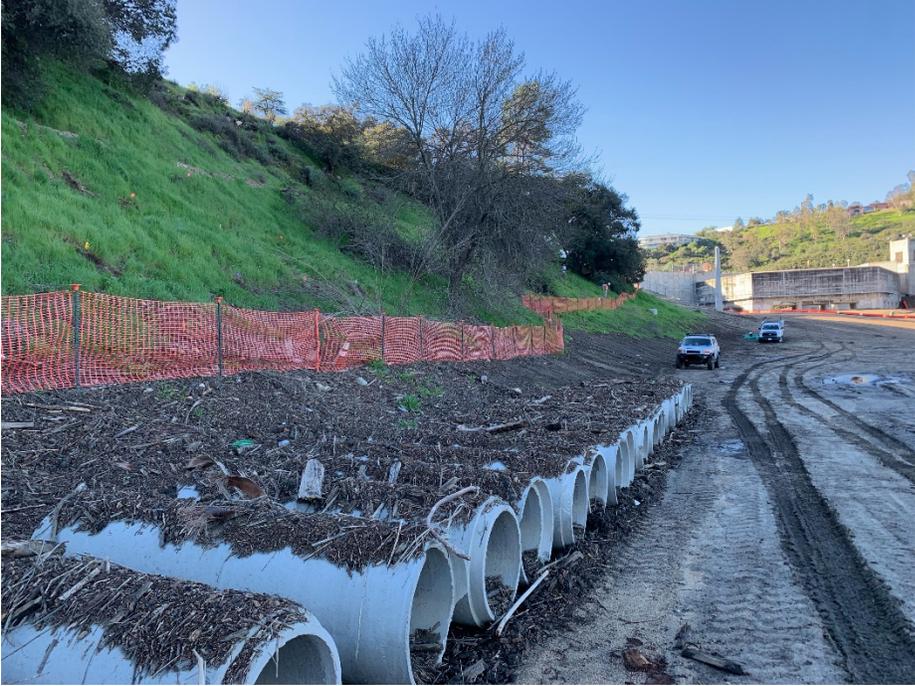
0750- monitored weed spraying in DG-3A. No sensitive species or nesting birds observed.

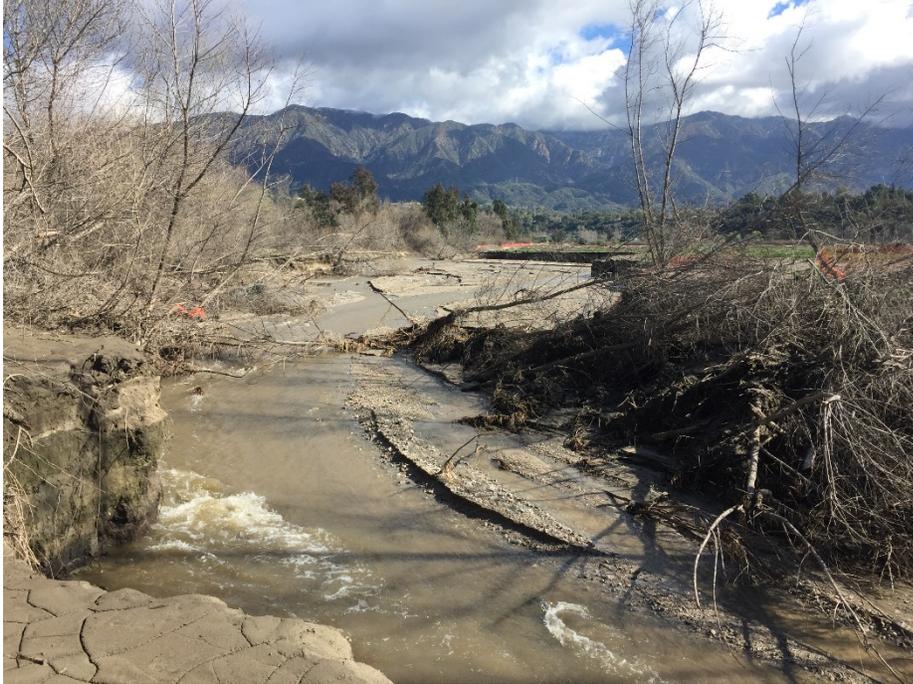
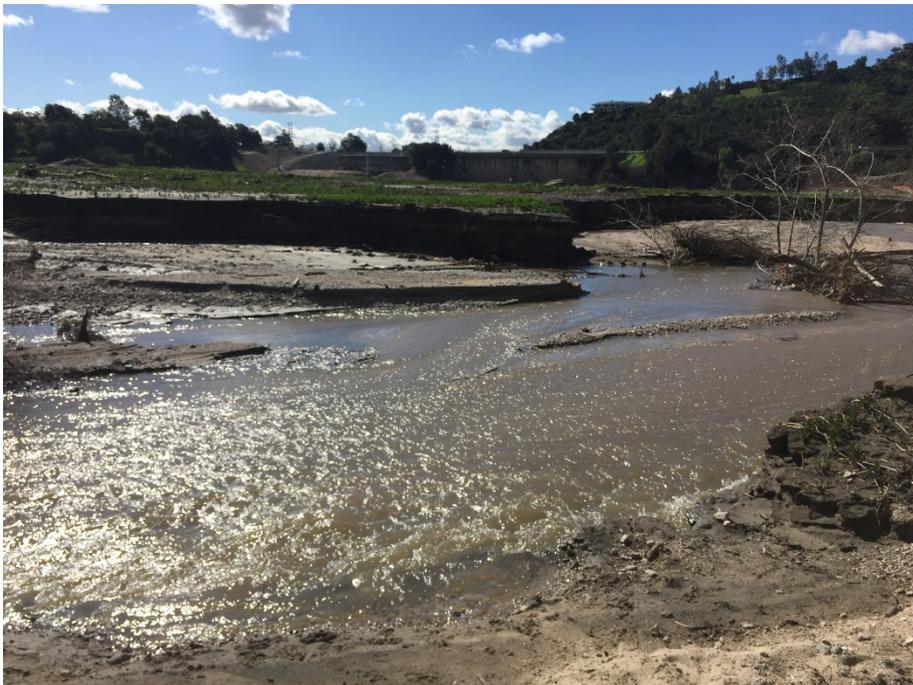
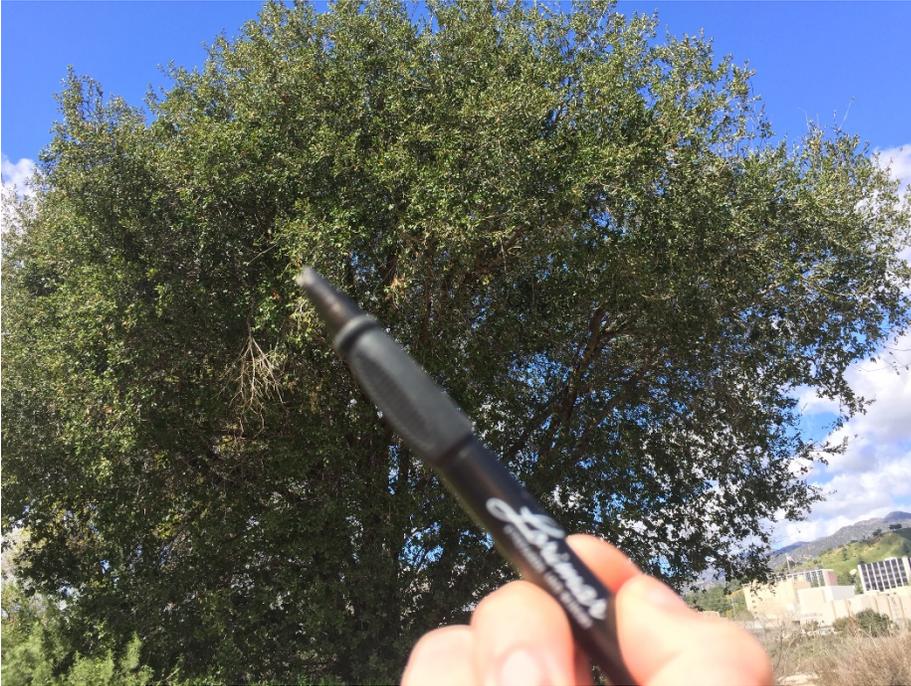
0830 Arrived on site and began site inspection and also to look for LBVI and nesting birds. One CASJ nest found at NE corner of the site. 200ft buffet established. Notified Griffith foreman. Logged in Collector. No noncompliance issues observed. Fencing will need repair before project starts again. Project is in compliance with all ESA conditions. No LBVI observed.

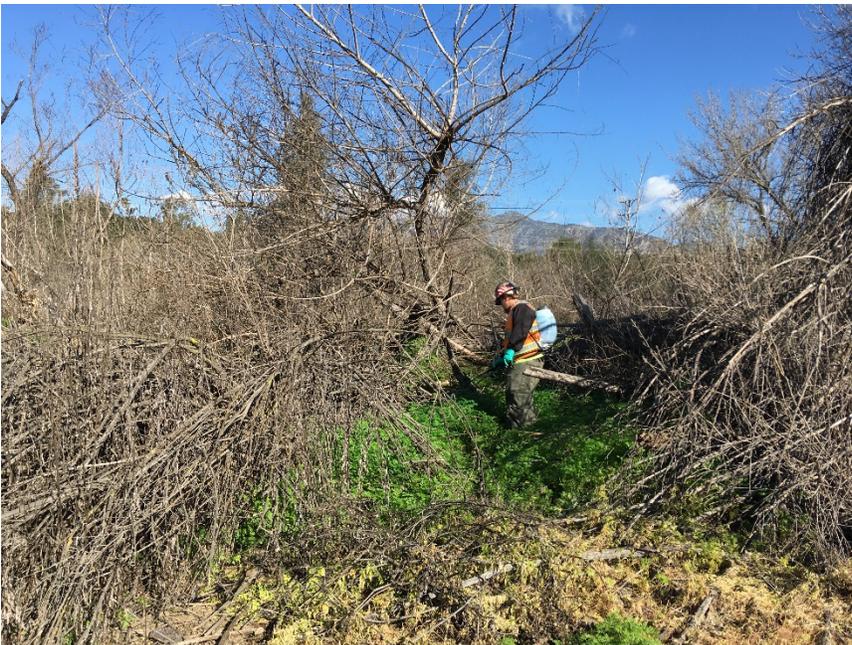
0915, crew began using backpack sprayers to treat nonnative plants.

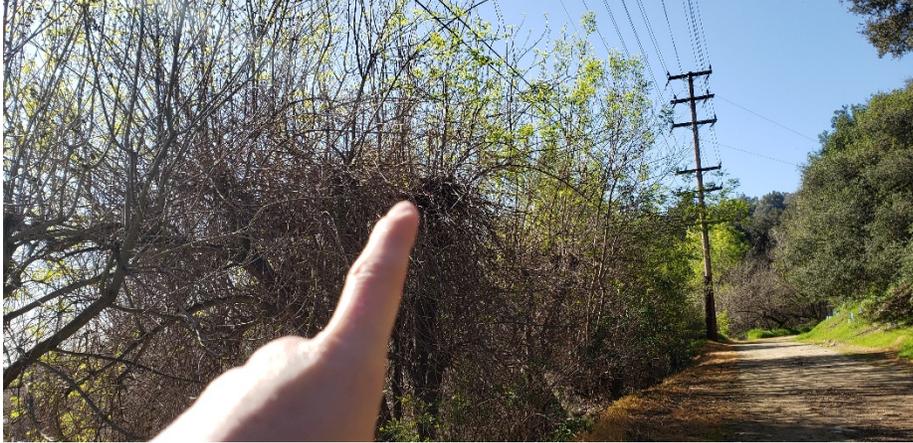
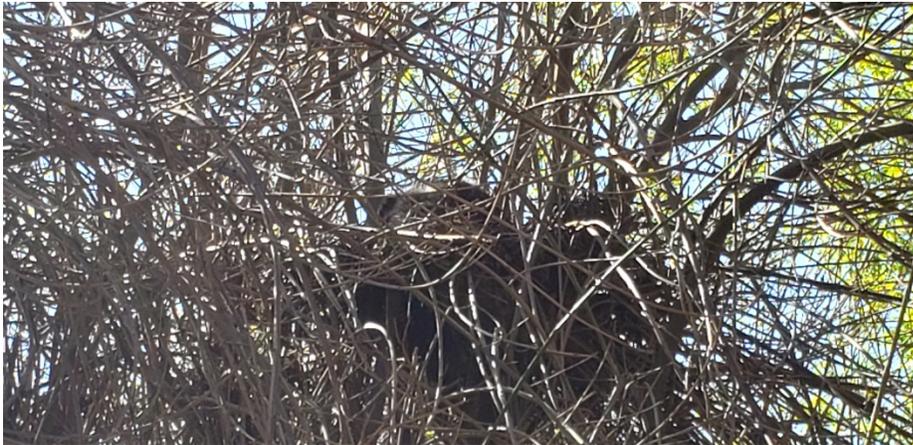
Common raccoon sleeping on stickpile in shamel ash tree immediately east of trail and restiration area (DG-4). Location recorded in Collector App.

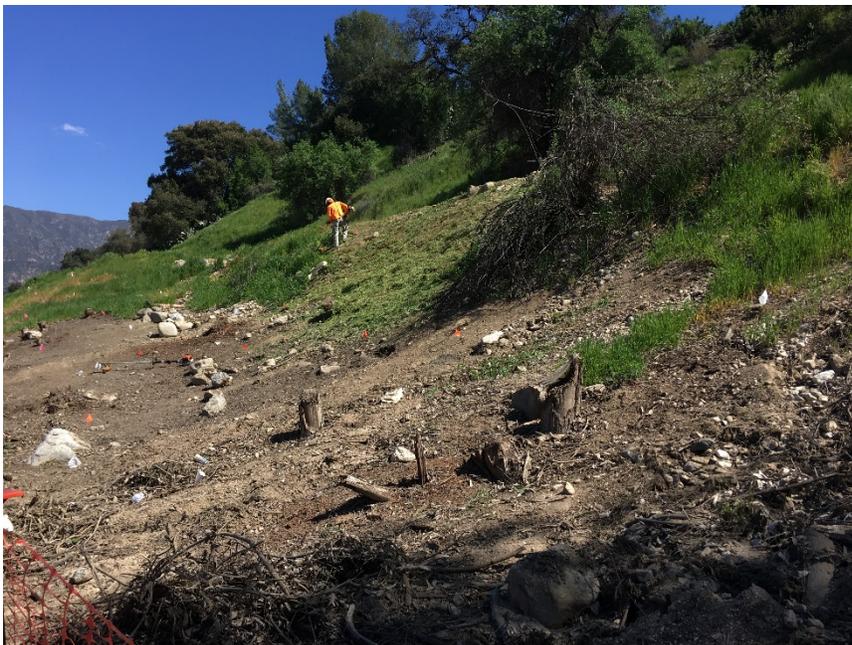
0715, Crew began removing material and placing it into piles to be tarped.

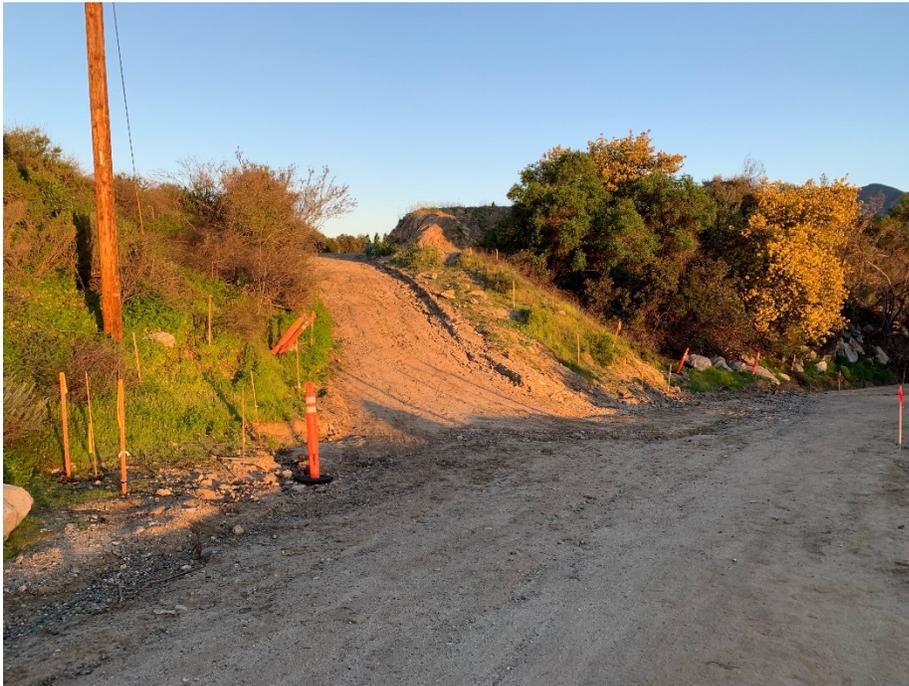
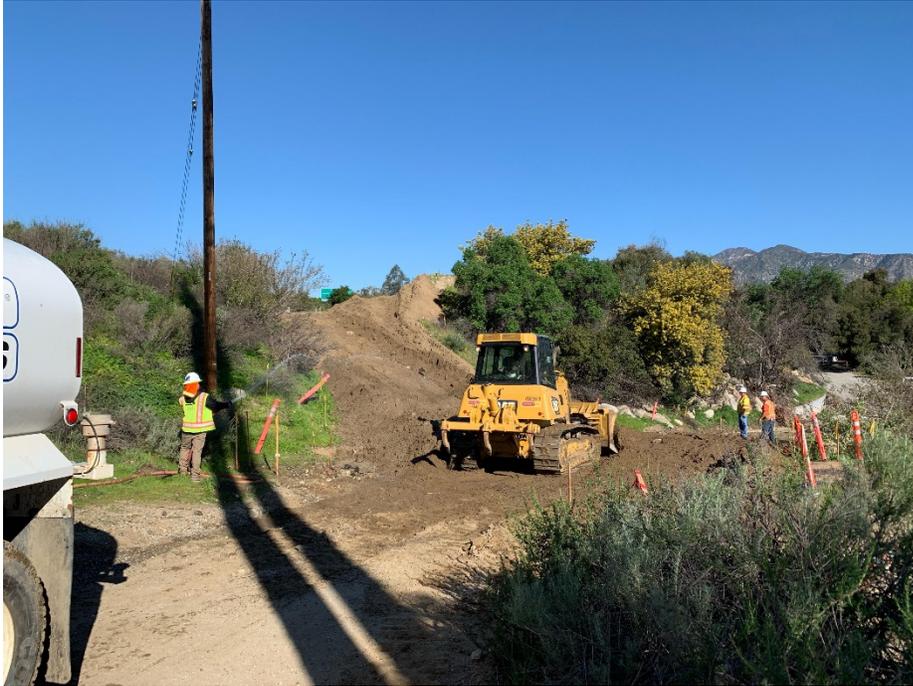
0805, Monitored road grading on the western access road. Two new nests were identified (both ANHU). No LBVI were observed and all activities were compliant with the Project's ESA measures.

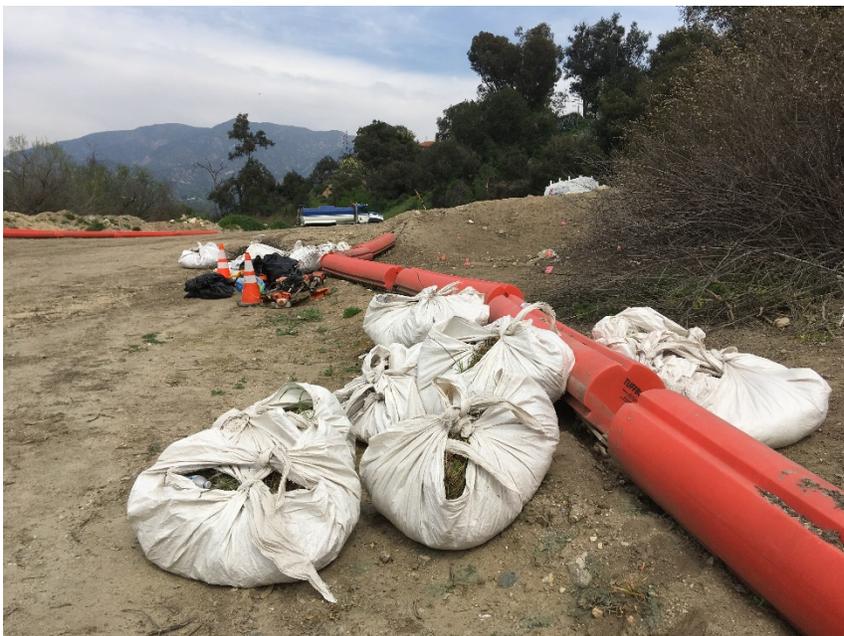
0715, Crew began removing material and placing onto tarps. Material will be stored in tarps overnight until dumpster arrives tomorrow morning.

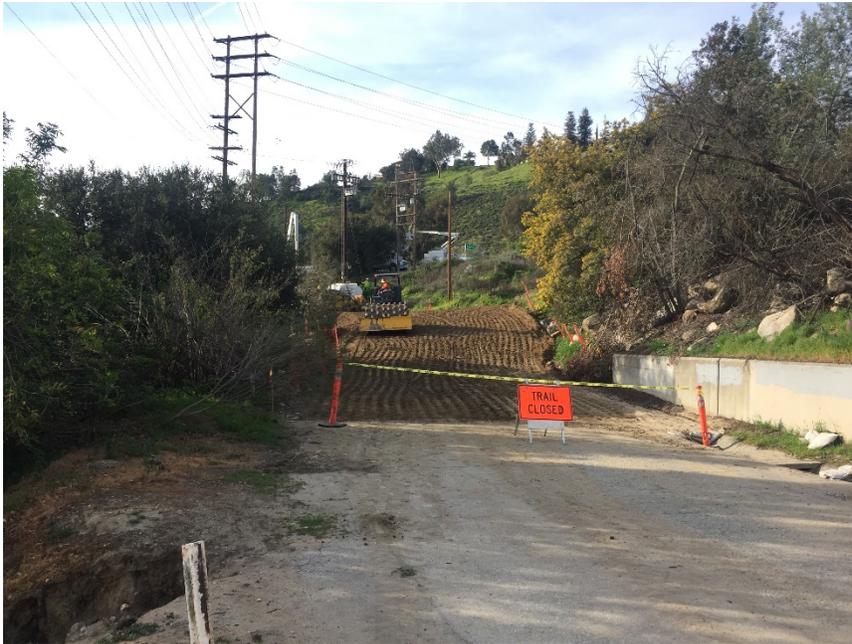
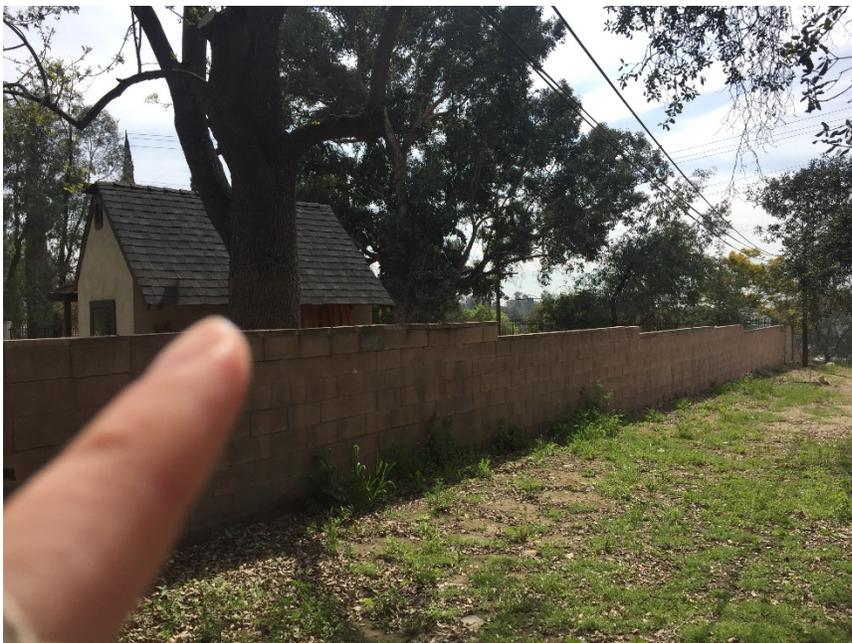
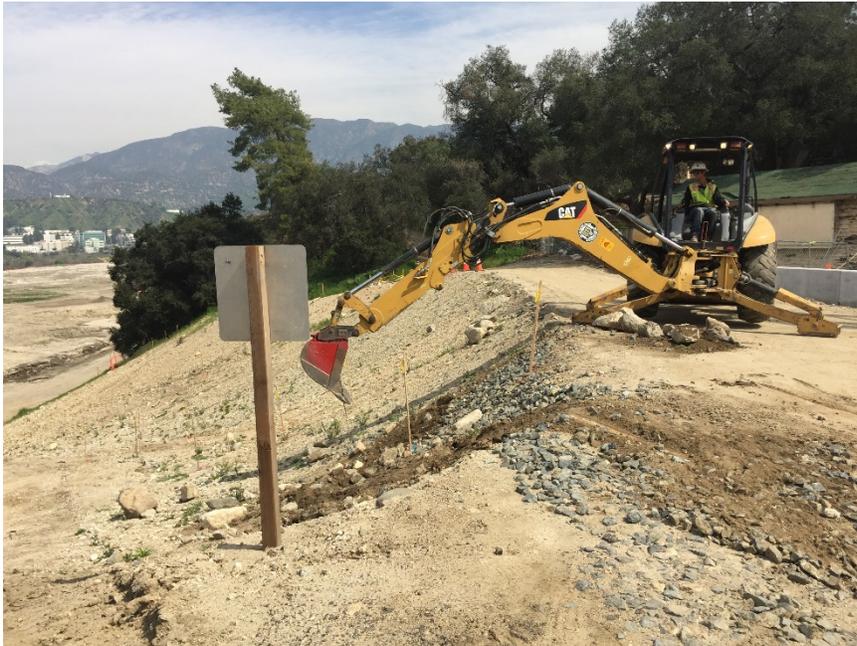
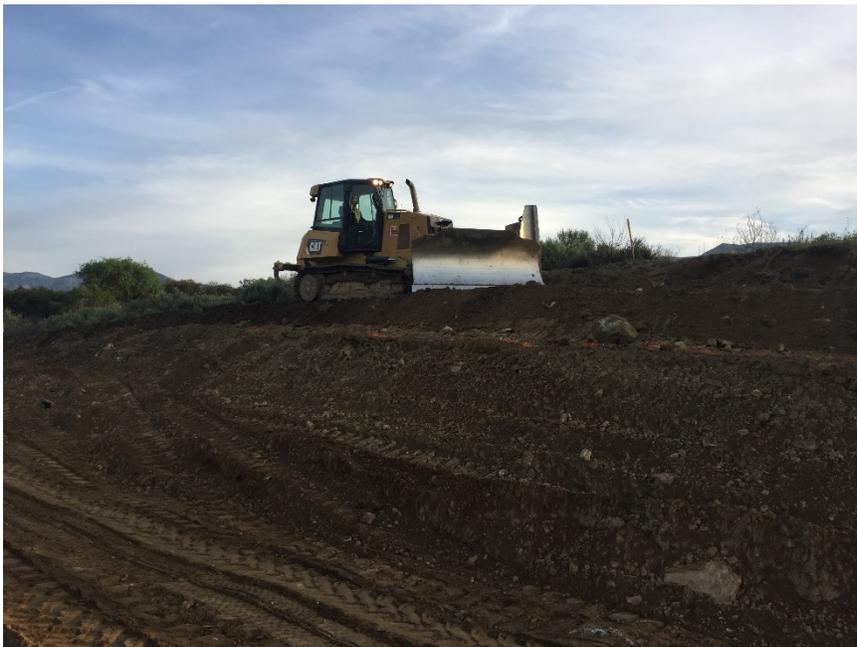
0655 Arrived on site and attended tailboard. 0705 Trained 1 Griffith crew member. 0730 Crew began taking down dirt along west access road. Checked ANHU-2 and ANHU-3 both incubating and not affected by work. New nest MODO-1 discovered, nest building. Outside of work area, 50ft buffer established. Will not affect work 1030 crew moved to east access road work, compacting soil near retaining wall and excavating north of Krail. Checked ANHU 1, female observed bringing nesting material to and sitting on nest, may be on 2nd brood. New nest

BLPH-1 located east of trailers on private property. Buffer established will not affect work. 1500 Crew wrapping up. No bio issues observed. No LBVI observed. Activities were compliant with ESA permit conditions.

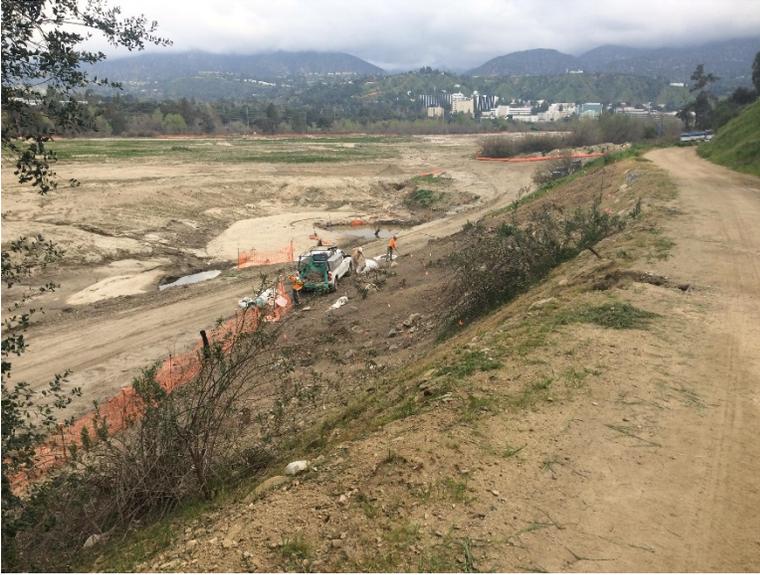
O730: Tarping of vegetation spoils within DG-3A. Use of hand tools. No herbicide. No issues observed.

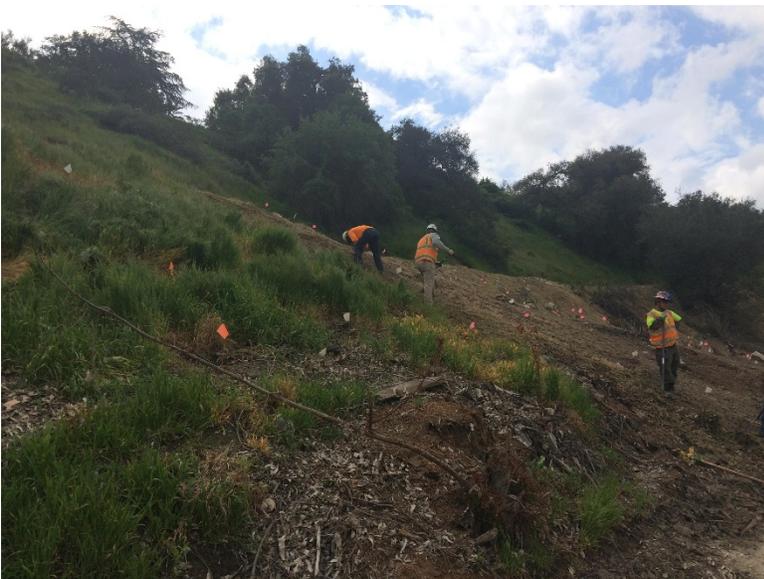
10:30- Line trimming nonnative grasses in DG-3A. Tarping of soils for disposal. Two alligator lizards relocated.

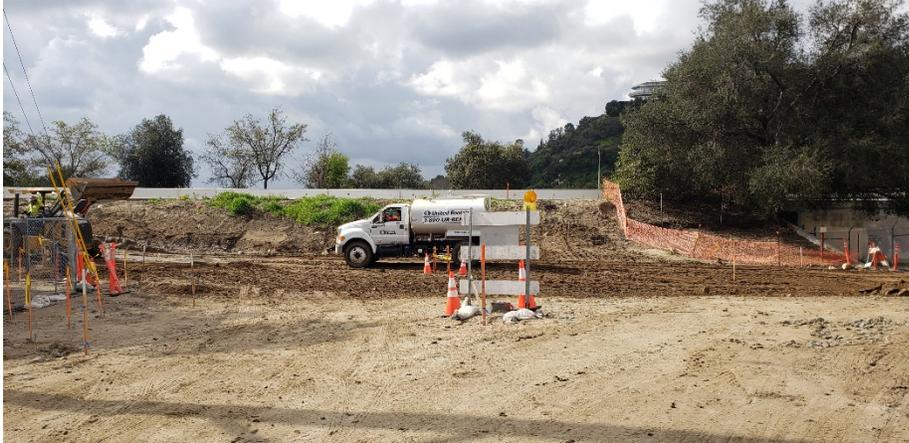
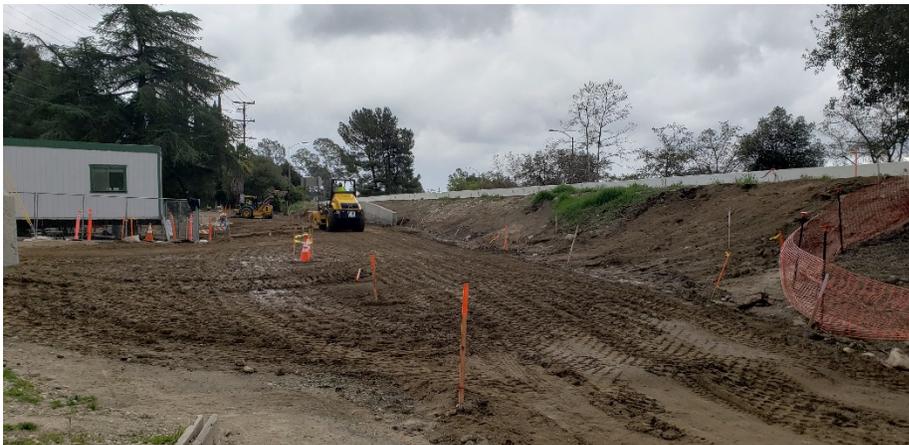
Griffith crew smoothing newly transported dirt with sheep's toe roller and filling eastern access road area.

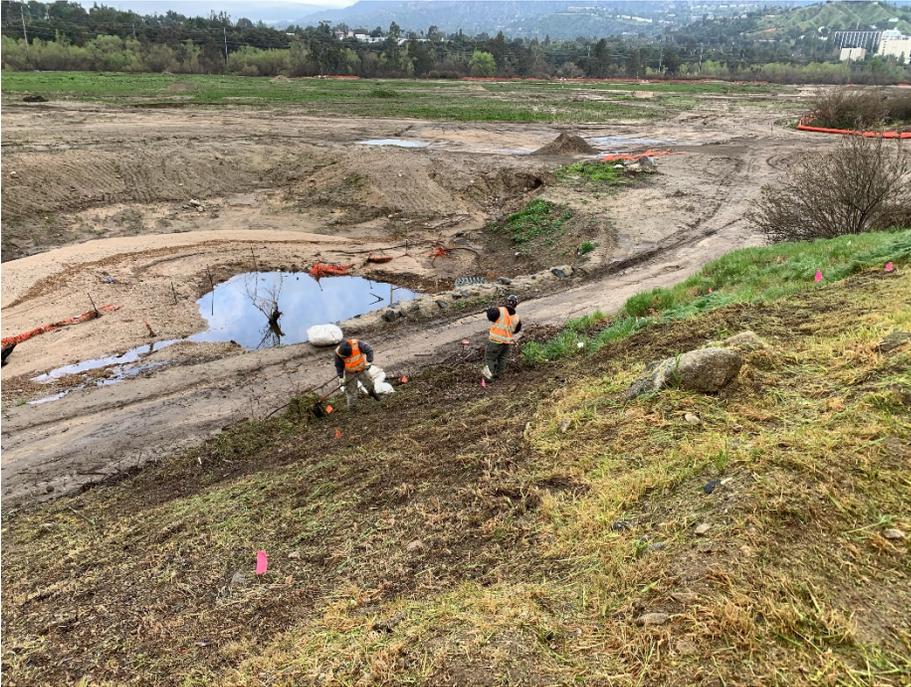
0710, monitored nonnative plant removal with weed eaters and hand tools in DG-3A. One western toad was relocated. No LBVI were observed and all activities were compliant with the Project's ESA measures.

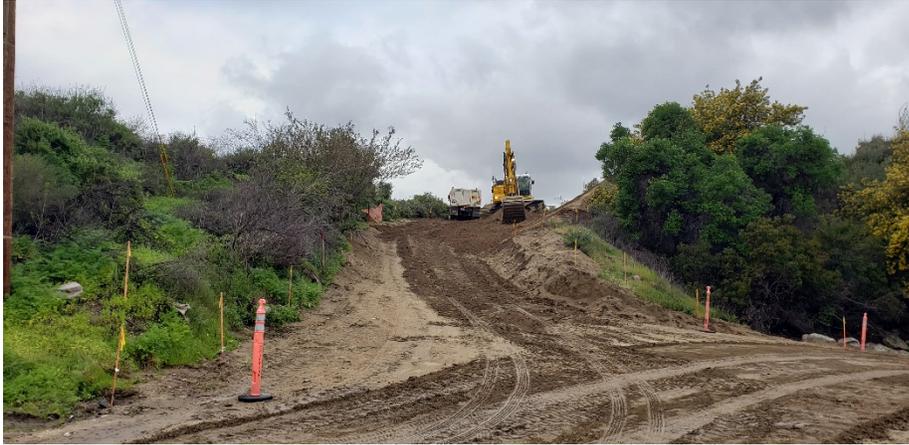
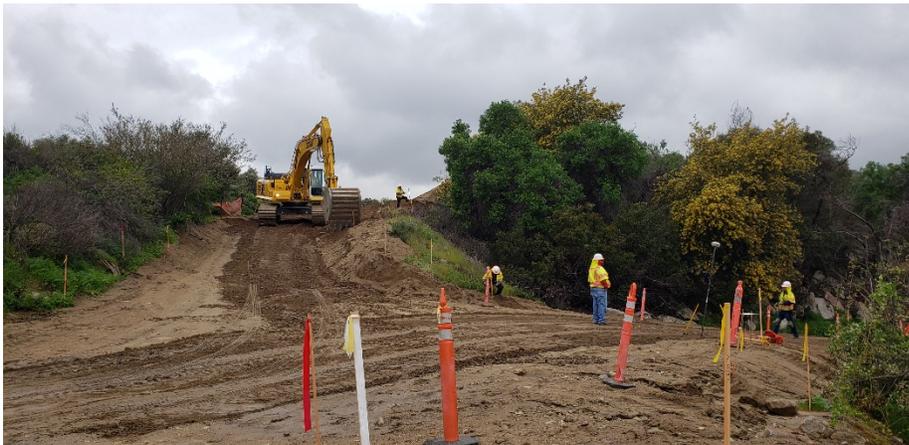
0730 Crew began loading haul trucks with one excavator in western access road area and smooth northern slope of access road. By 0900 a LACDPW crew was taking measurements and staking along the access road/asphalt trail. MODO observed on MODO-1 while male perched next to nest.

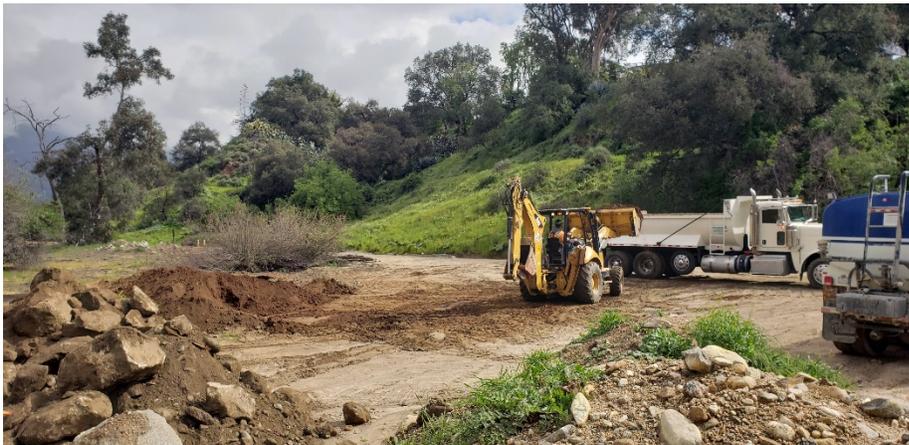
1050 Griffith crew loading previously stockpiled dirt into haul trucks with backhoe in lower staging area east of sediment removal area and north of construction/trailer yard. Crew (excavator and spotter) done working on western access road. Dirt hauled to fill eastern access road.

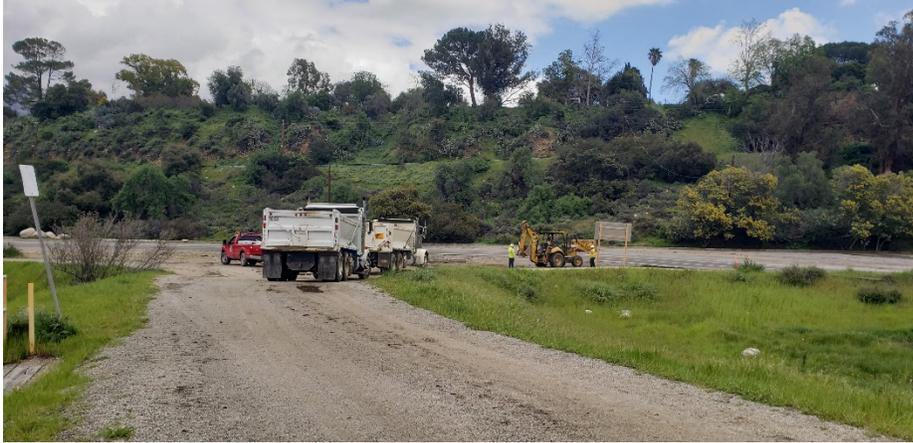
1327 Crew done on eastern access road and in lower staging area. They moved to northern access road entrance to work on shaker plates. Confirmed with Joe that no other work was planned that required a monitor and then left the site.

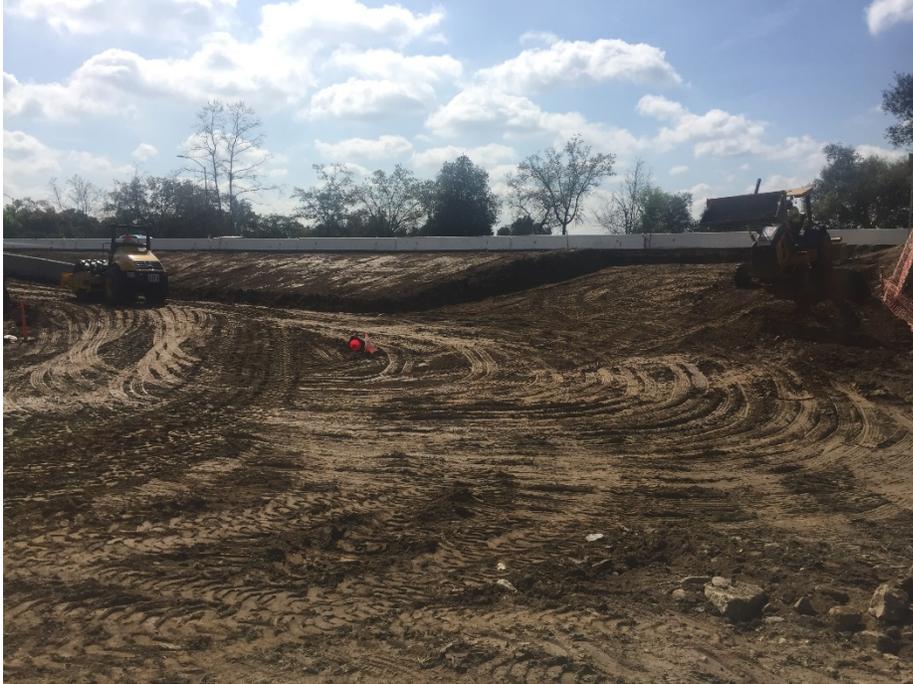
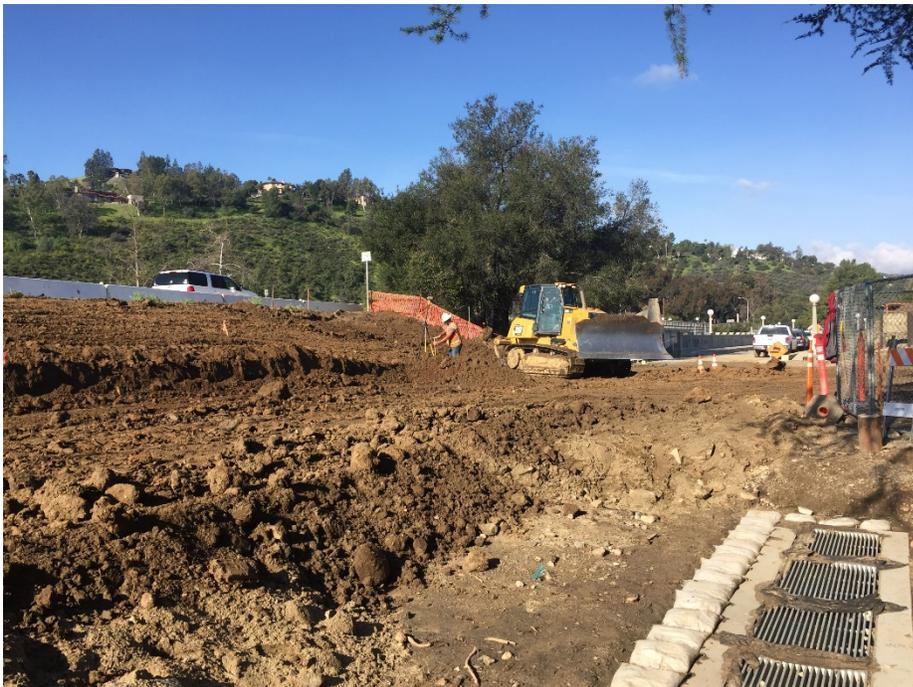
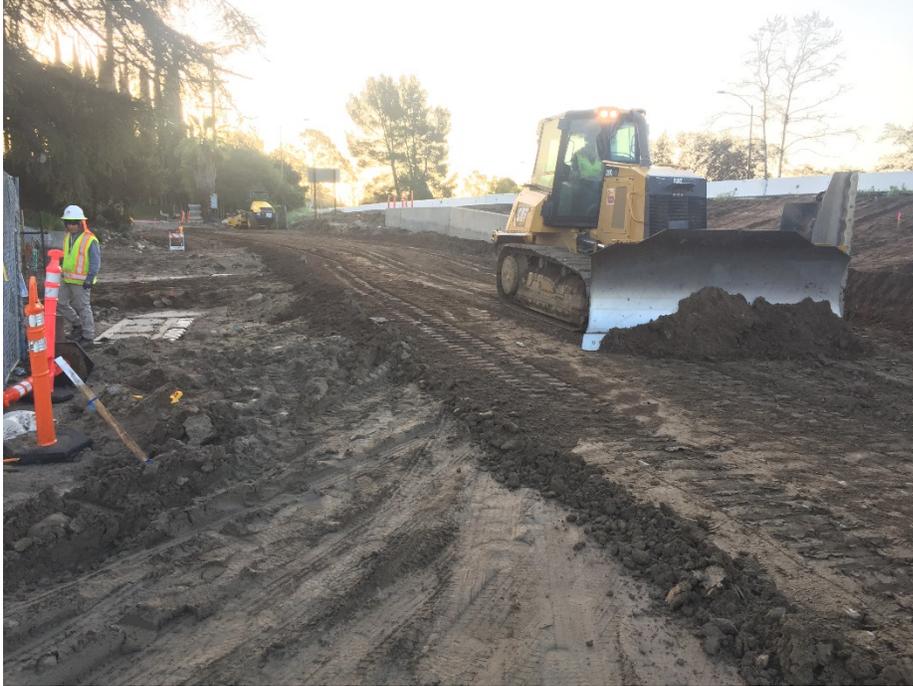
0645 arrived on site, discussed work plan for day. Swept area. 0715 crew prepping road for dump trucks 0800 dump trucks began depositing fill at east access road. Observed ANHU-1 incubating on nest at several points throughout day, does not appear affected by current work activities. Observed BLPH-1 nest building activities continuing through day. No new nests observed. 1000 was summoned by NI crew to relocate baby rattlesnake found during restoration activities. Relocated to south side of dam to prevent re-encounter. 1300 crew continuing road formation in east side. 1500 biologist left site. No bio issues observed. No LBVi observed. Project activities were compliant with permit conditions.

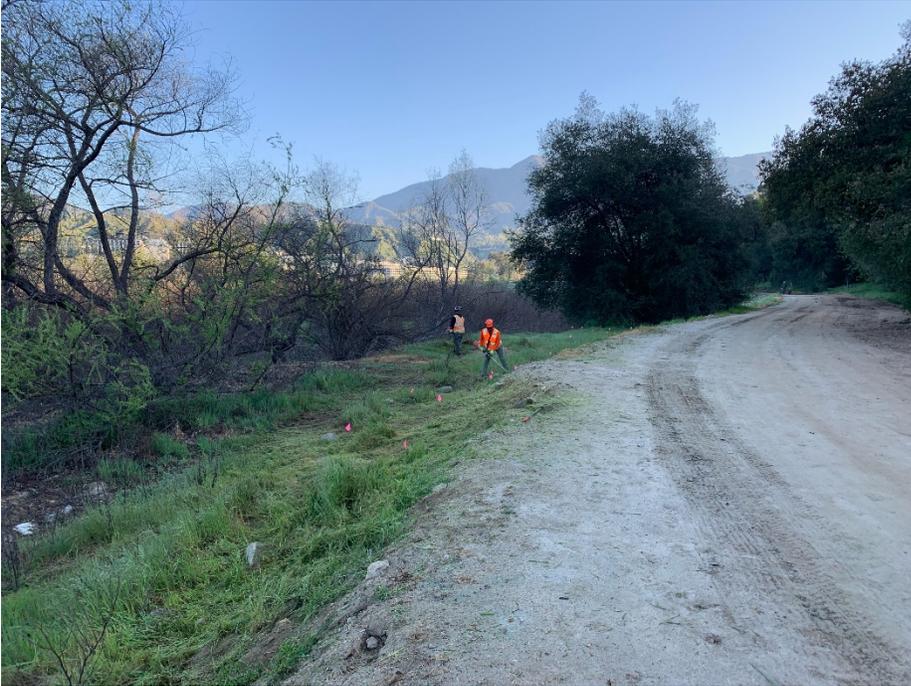
0700, monitored restoration crew clearing grasses in preparation for spreading seed in DG-2A. Three nests (one CASJ, one ANHU, and one BUSH) were identified. No LBVI were observed and all activities were compliant with the Project's ESA measures.

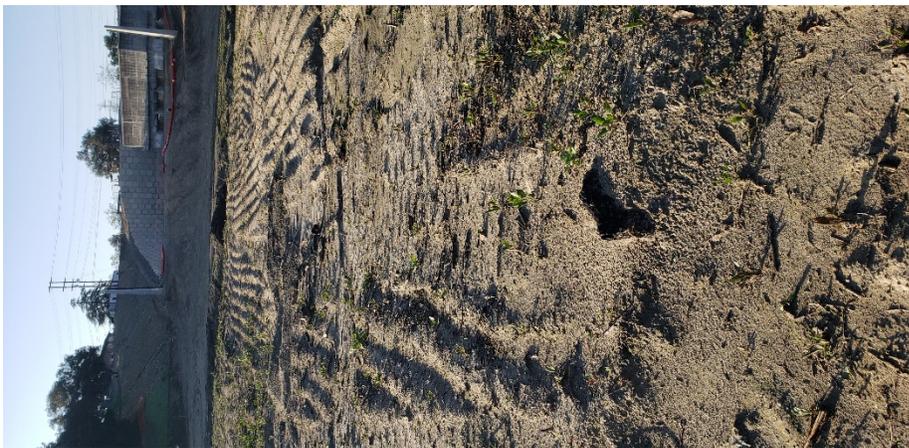
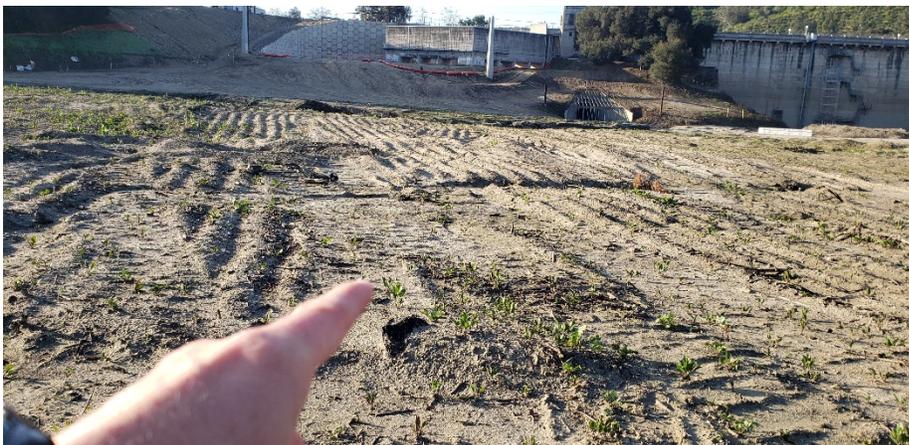
0830 Investigated potential Killdeer nest, reported by citizen, located in reservoir. Pair were observed in location with 1 sitting in depression. Pair walked away as biologist approached, vocalized quietly and did not perform broken wing display. Depression and surrounding area was inspected for sign of nesting but no sign, including eggs, was observed. Location recorded in Collector. It is SE of water truck/access road through reservoir.

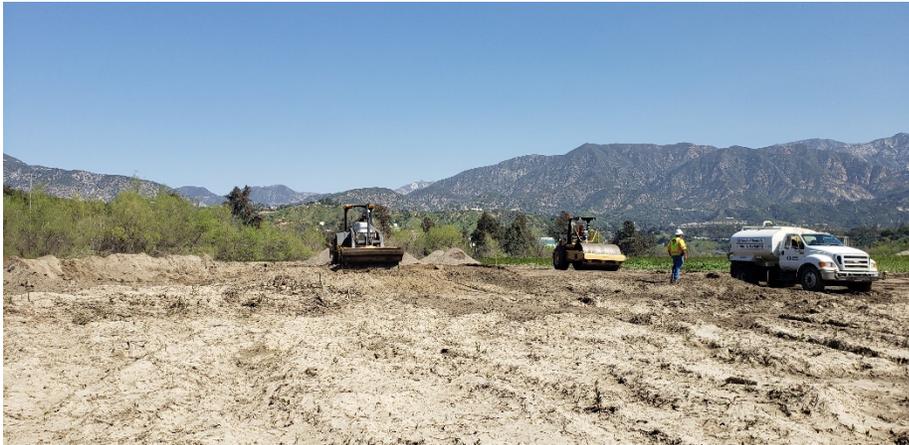
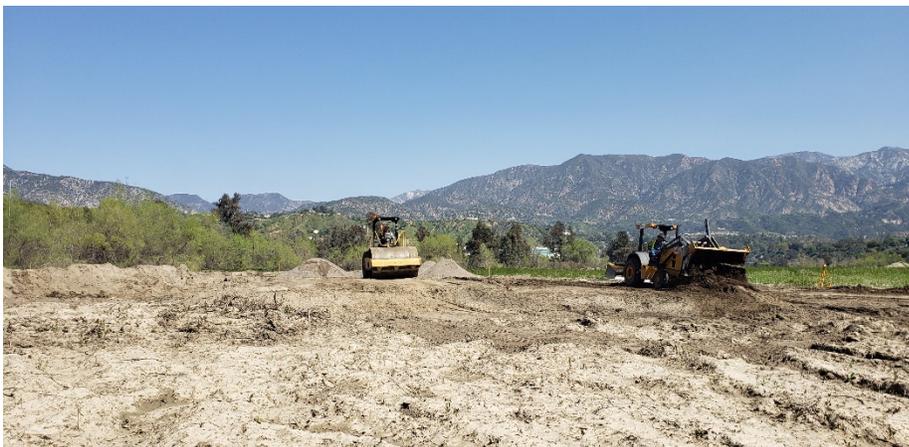
0830-1121 Crew continued to work on area planned for scales in west side of reservoir. Backhoe still in operation but sheep's toe roller switched out for flat roller. Backhoe pushing

dirt, in ANHU-3 buffer while biologist observed nest. ANHU continued to incubate while work activities occurred within 115 feet. No disturbances were observed. Documented 3 new nests in adjacent mitigation area west of Project site: ANHU-5, LEGO-1, and ANHU-7. Locations and observations recorded in Collector.

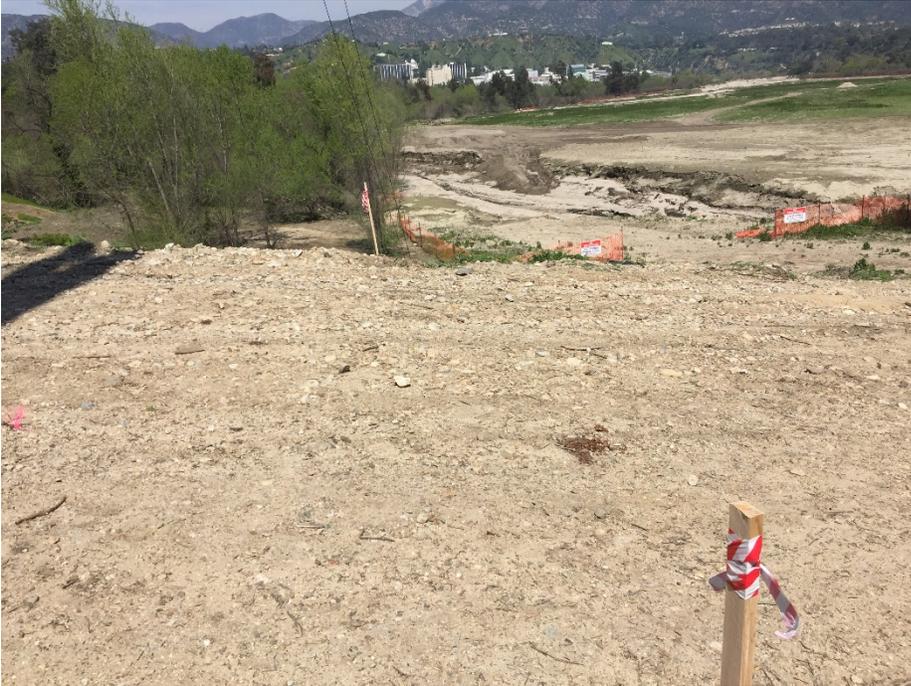
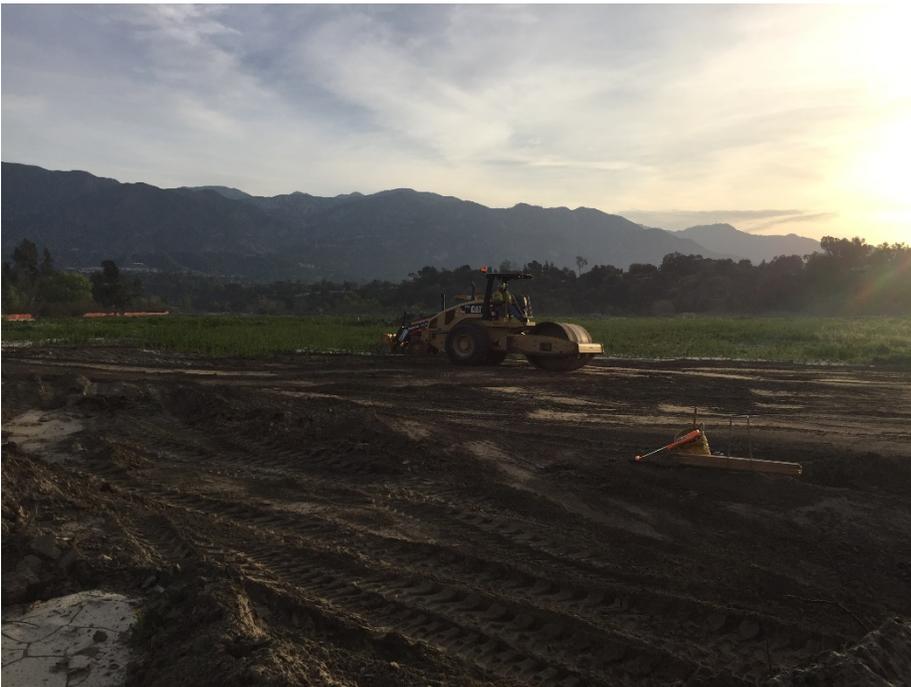
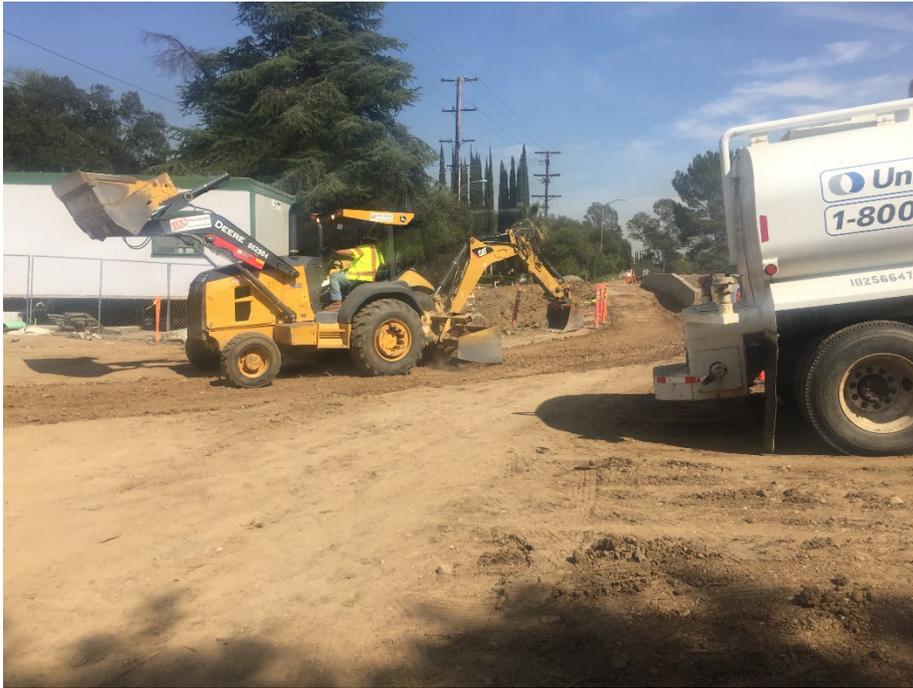
0650 arrived onsite, attended Griffith tailboard and got work plan for day. Discussed potential for killdeer nesting in reservoir. 0700 swept work area, searched for nests near southwest corner of site, found one new ANHU nest. Added 100ft buffer. Monitored soil movement for scale platform. No bio issues observed. No KILL observed. 1230 added staking around nest buffers where buffers extend into work area 1300 crew moved to west access road, monitored dirt scraping. 1530 biologist left site. No bio issues observed, no LBVI observed, all project activities compliant with permits.
