January 4, 2022
2018-047.030

Re: *Devil's Gate Reservoir Restoration Project – Phase 1 Restoration Qualitative Monitoring Conducted on November 19, 2021*

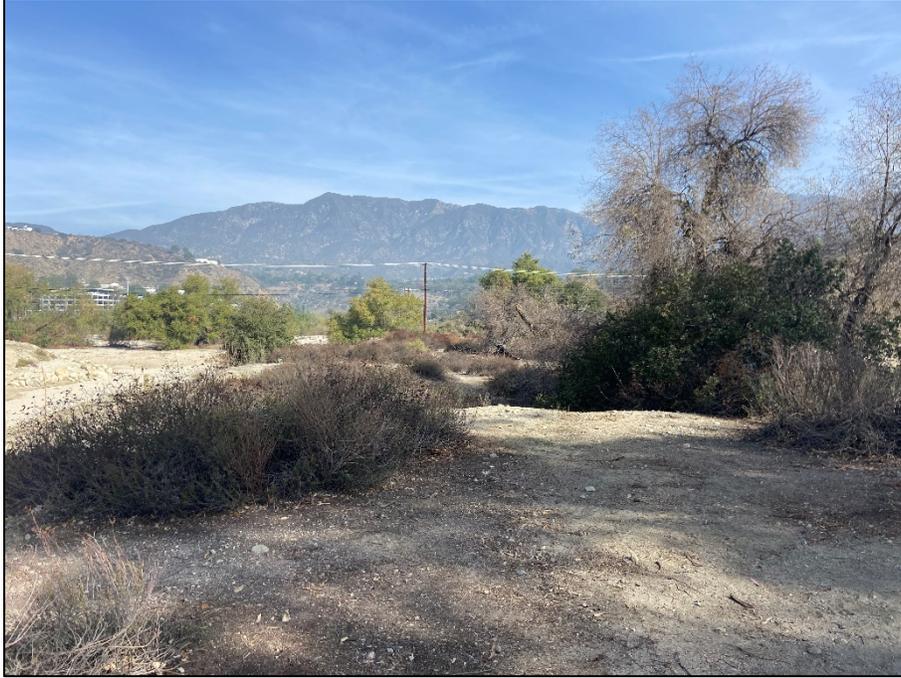
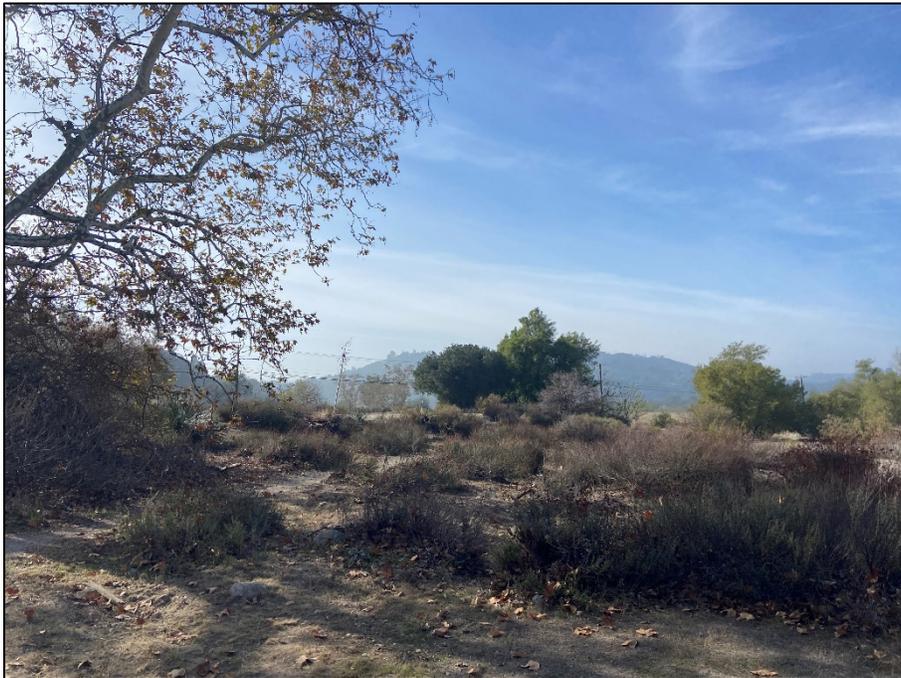
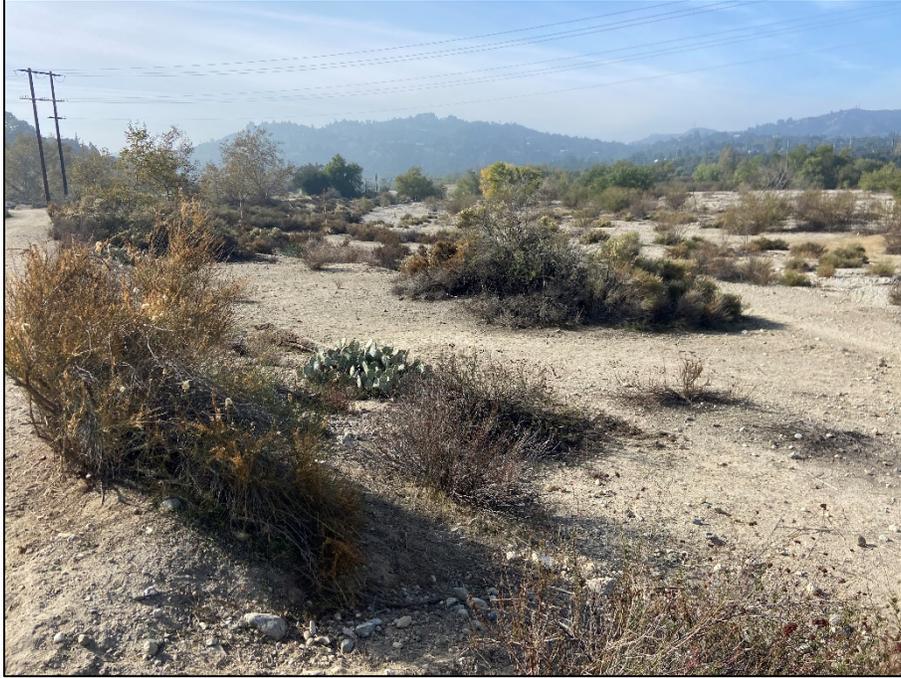
Photo 1: Overview Mitigation Area DG-1

Container plants were not installed in the DG-1 or DG-1 WOUS mitigation areas, but these areas were seeded with native plant species. Native plant growth was noted throughout the DG-1 and DG-1 WOUS mitigation areas, likely both from natural recruitment and from seeding; however, germination was observed to be very minimal in the majority of these mitigation areas. Portions of DG-1 WOUS were noted as being scoured during the 2020 wet season and had minimal plant growth. Native plants such as California buckwheat (*Eriogonum fasciculatum*), chaparral yucca (*Hesperoyucca whipplei*), caterpillar phacelia (*Phacelia cicutaria*), ladies' tobacco (*Pseudognaphalium californicum*), and scale broom (*Lepidospartum squamatum*) were observed sprouting in the DG-1 and DG-1 WOUS mitigation areas. In addition, dodder (*Cuscuta sp.*) was observed growing on some of the shrubs in this mitigation area, which could lead to future decline of these shrubs. Native cover for the DG-1 and DG-1 WOUS mitigation areas was estimated to be 55 to 60 percent with some areas having relatively dense cover and other areas being scoured and/or having minimal cover. Photos 1 through 4 in Attachment B document the mitigation area during the monitoring visit.

During the monitoring visit, tracks from heavy machinery were observed within the Southern California Edison (SCE) easement portion of DG-1; however, no damage to native plants were observed. The heavy machinery tracks are likely from the recent pole work conducted by SCE within their easement.

Nonnative weed cover in DG-1 and DG-1 WOUS was estimated at approximately five percent, if the dead annual weeds are excluded, which is approximately 5 percent higher than the level of weed cover that was observed during the previous qualitative monitoring event. Nonnative species observed in DG-1 and DG-1 WOUS included black mustard (*Brassica nigra*), red-stemmed filaree (*Erodium cicutarium*), and Mediterranean grass (*Schismus barbatus*). All nonnative weeds were just starting to germinate and had not gone to flower or seed.

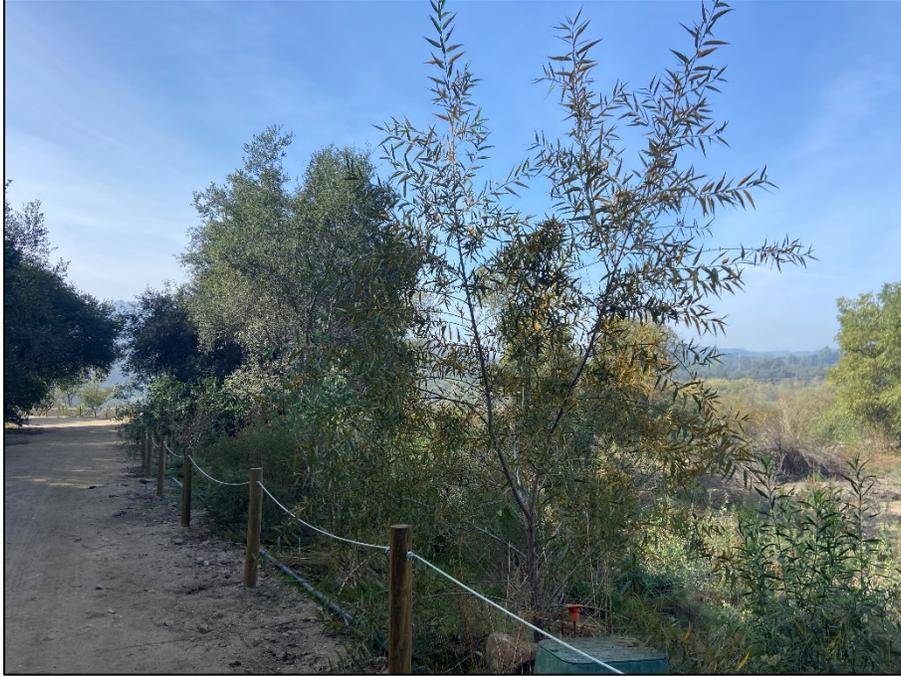
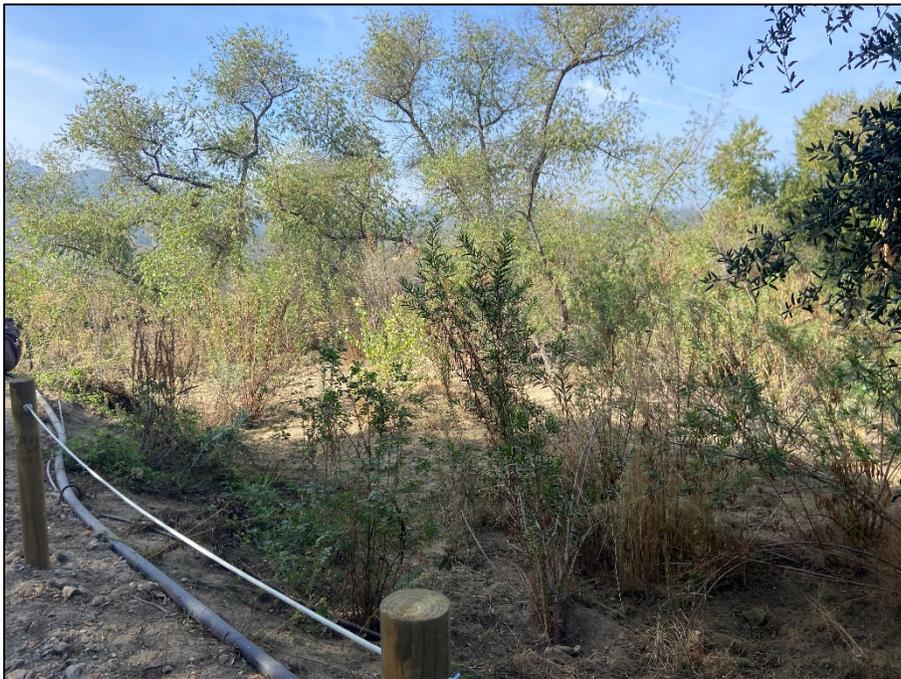
Photo 5: Overview Mitigation Area DG-2A

The overall health of the container plants in DG-2A was noted as being good. Approximately 5 percent of the container plants in DG-2A were noted as showing varied levels of stress, which is approximately 10 percent less than the percentage of container plants that were showing stress during the previous qualitative monitoring event. Stress may be occurring as a result of 1) herbivory by rabbits or other wildlife, 2) competition from nonnative and invasive weeds, 3) misplaced emitters, or 4) recreational traffic through the mitigation areas. There were no additional container plants noted as being missing or dead. Formal mortality counts were taken for DG-2A during the 2020 quantitative monitoring and were included in the 2020 annual reporting. Seasonal dieback was noted for the willows (*Salix* sp.) and the Fremont's cottonwoods (*Populus fremontii*). Some of the planting basins were observed to have minor erosion and should be repaired. The installation of plants in the DG-2A mitigation area appears to have been completed successfully. The current issues identified during the monitoring visit are not expected to have an effect on the continued growth of the plants in the mitigation area. Photos 5 through 6 in Attachment B document the mitigation area during the monitoring visit.

Native plant growth was noted throughout the DG-2A mitigation area, likely both from natural recruitment and from seeding. Native plants such as annual bursage (*Ambrosia acanthicarpa*), mugwort (*Artemisia douglasiana*), Canada horseweed (*Erigeron canadensis*), telegraph weed (*Heterotheca grandiflora*), and stinging nettle (*Urtica dioica*) were observed sprouting in the DG-2A mitigation area. Native cover for the DG-2A mitigation area was estimated to be 60 to 65 percent.

Nonnative weed cover in DG-2A was estimated at approximately less than five percent, which is approximately the same level of weed cover that was observed during the previous qualitative monitoring event. This site was noted as being actively weeded during the monitoring visit. Nonnative species observed in DG-2A included wild oat (*Avena fatua*), black mustard, poison hemlock (*Conium maculatum*), and perennial pepperweed (*Lepidium latifolium*). All nonnative weeds were just starting to germinate and had not gone to flower or seed.

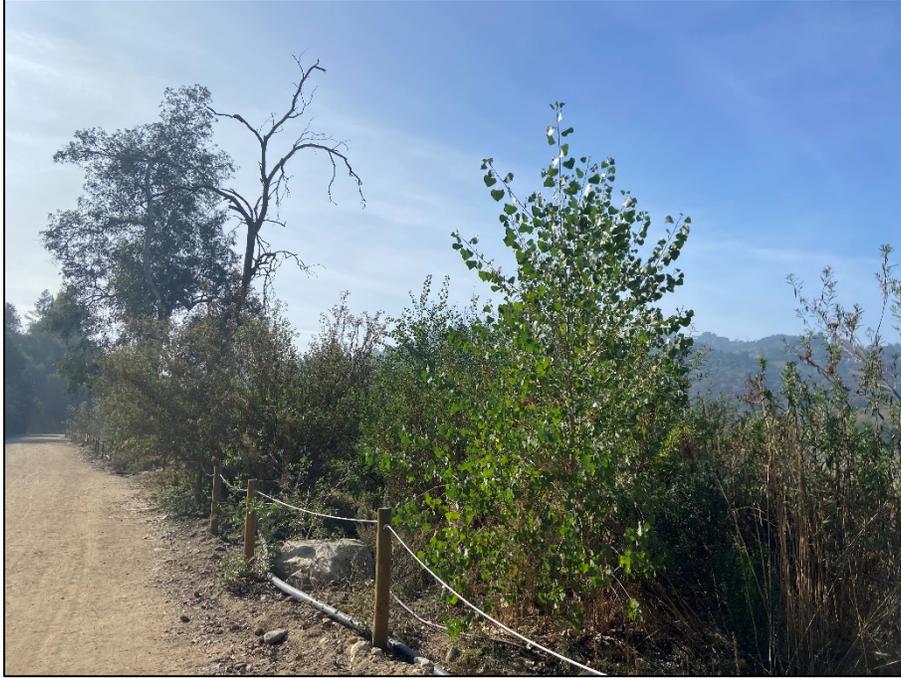
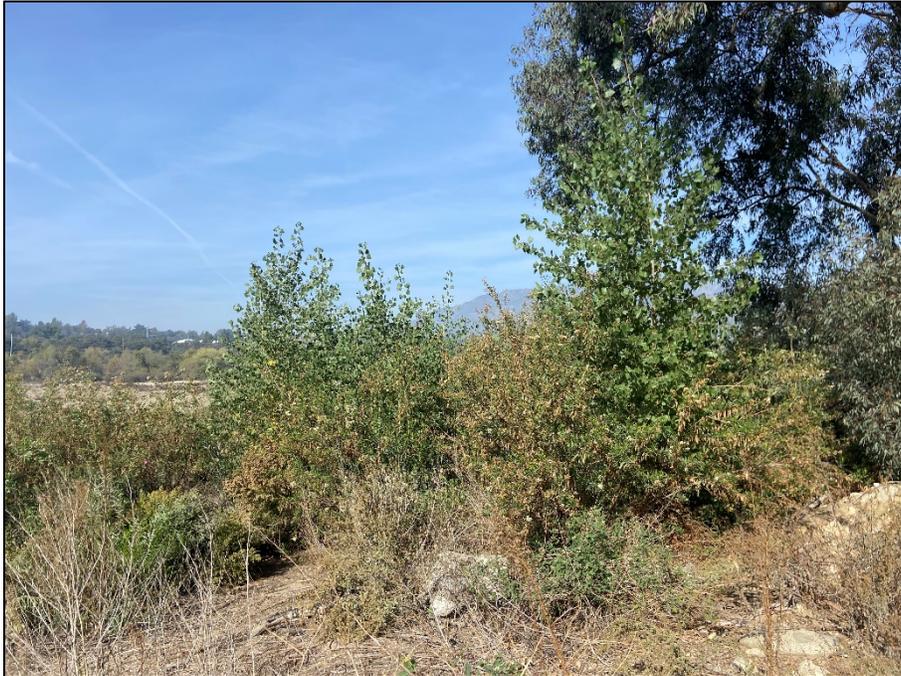
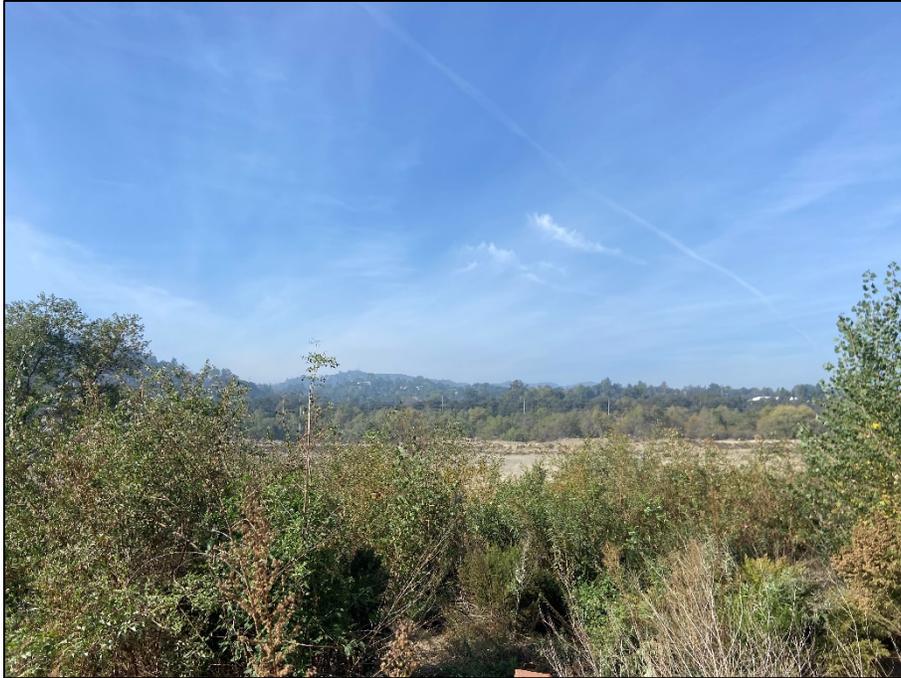
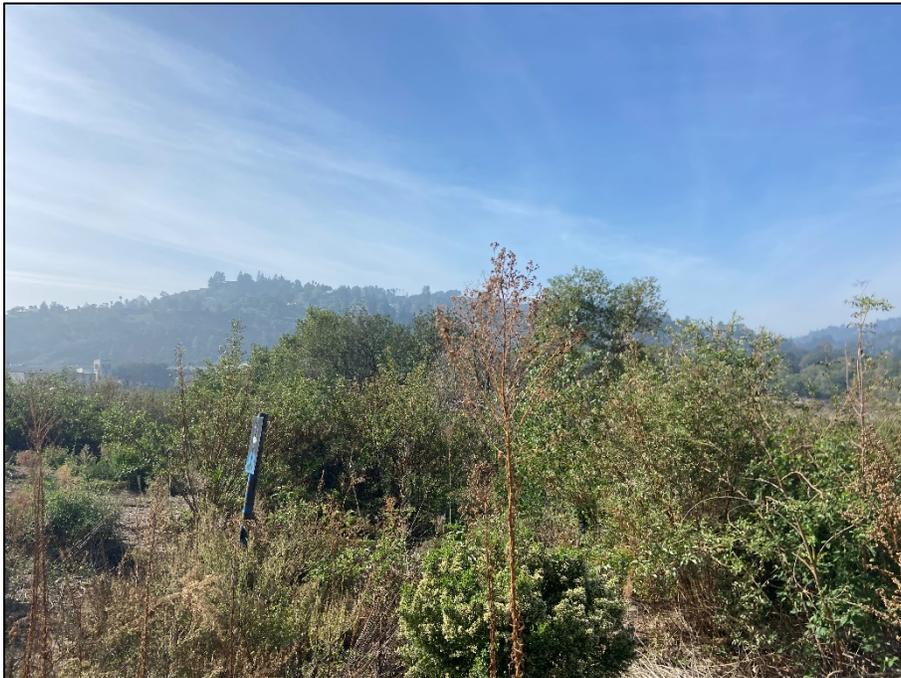
Photo 7: Overview Mitigation Area DG-2B

The overall health of the container plants in DG-2B was noted as being good. Approximately less than five percent of the container plants in DG-2B were noted as showing varied levels of stress, which is approximately the same percentage of container plants that were showing stress during the previous qualitative monitoring event. Stress was likely due to the same reasons as those described for DG-2A. In addition, insect galls were observed on several of the willow species. Formal mortality counts were taken for DG-2B during the 2020 quantitative monitoring and were included in the 2020 annual reporting. Similar to DG-2A, some of the willows and Fremont's cottonwoods were showing signs of seasonal dieback. Some of the planting basins were observed to have minor erosion and should be repaired. The installation of the plants in the DG-2B mitigation area appears to have been successfully completed. The current issues identified during the monitoring visit are not expected to have an effect on the continued growth of plants in the mitigation area. Photos 7 through 10 in Attachment B document the mitigation area during the monitoring visit.

Native plant growth was noted throughout the DG-2B mitigation area, likely both from natural recruitment and from seeding. Native plants such as annual bursage, Canada horseweed, caterpillar phacelia and stinging nettle were observed sprouting in the DG-2B mitigation area. Native cover for the DG-2B mitigation area was estimated to be 65 to 70 percent.

Nonnative weed cover in DG-2B was estimated at approximately less than one percent, which is approximately five percent less than what was observed during the previous qualitative monitoring event. Nonnative species observed in DG-2B included black mustard and red-stemmed filaree. All nonnative weeds were just starting to germinate and had not gone to flower or seed. In addition, evidence of recent weeding was observed in the DG-2B mitigation area.

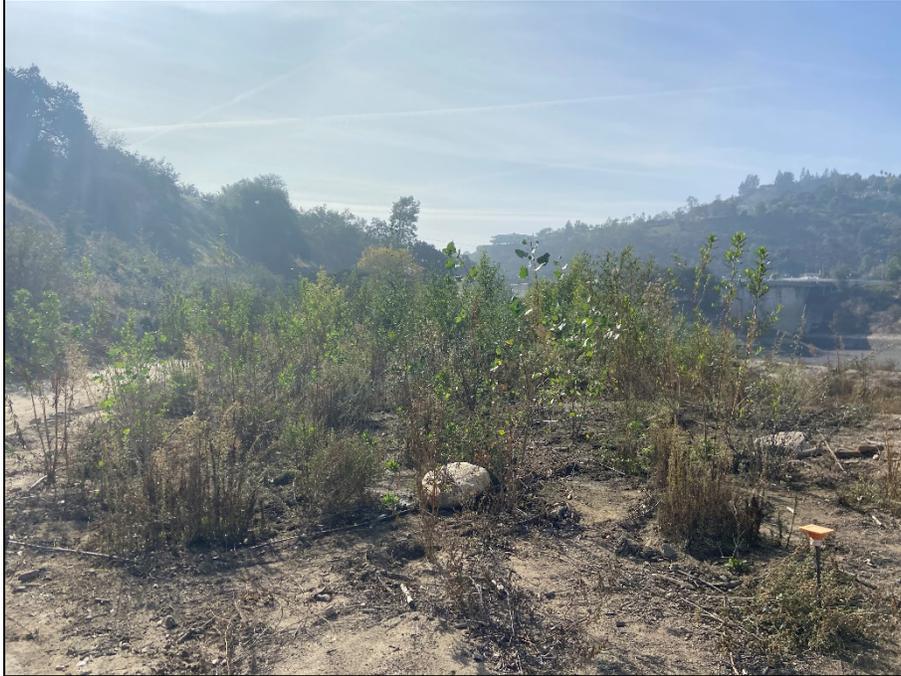
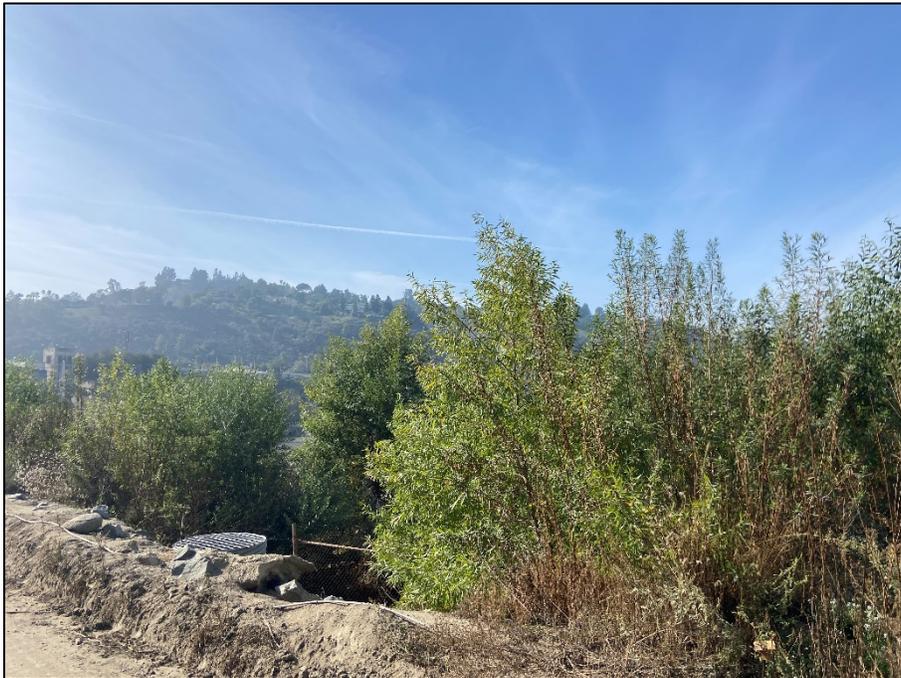
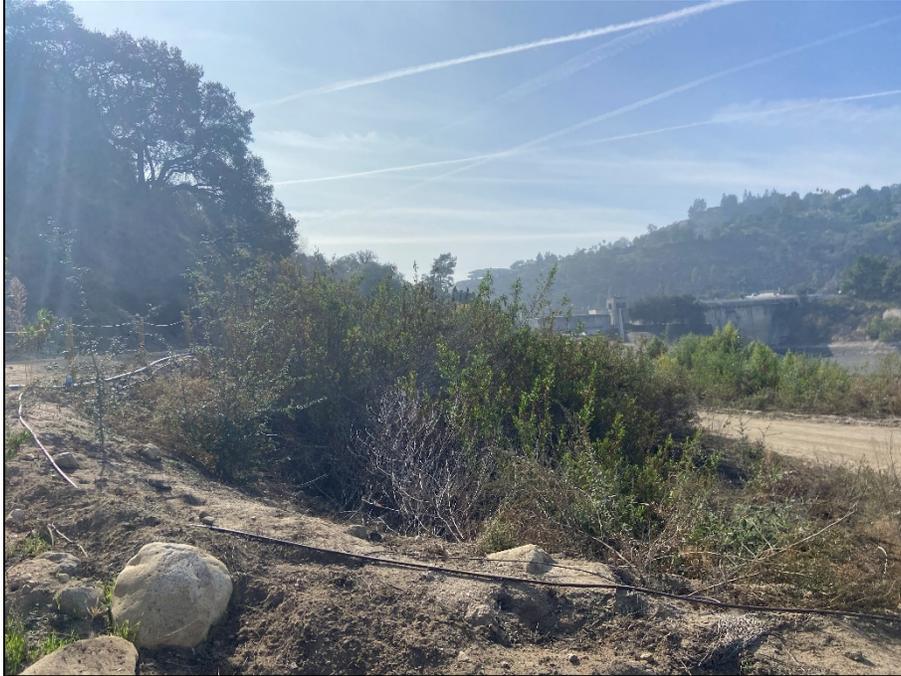
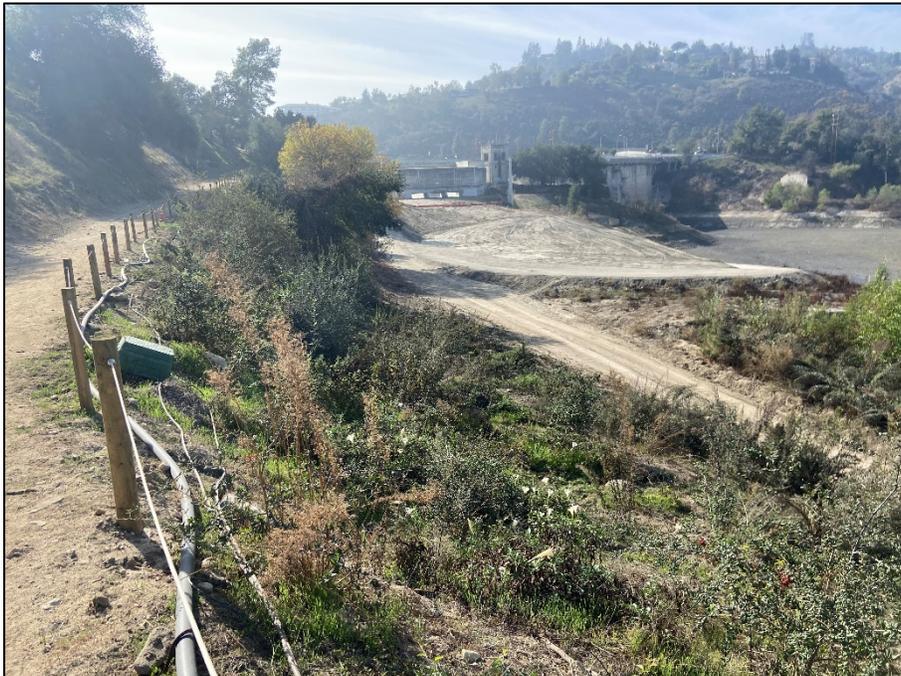
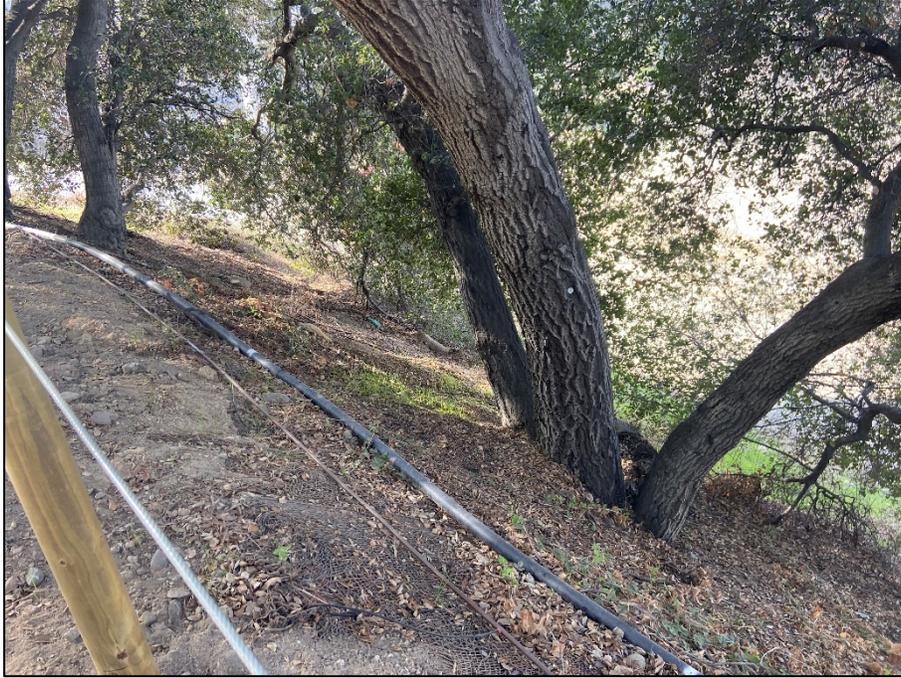
Photo 11: Overview Mitigation Area DG-3A Altadena Drain

The overall health of the container plants in DG-3A was noted as being good. Approximately five percent of the container plants in the Coast Live Oak Woodland portions of DG-3A were noted as showing varied levels of stress, which is approximately five percent less than the percentage of container plants that were showing stress during the previous qualitative monitoring event. In addition, several oaks were showing significant signs of decline and may not survive. The decline appears to be the result of erosion and misplaced emitters. Approximately five percent of the container plants in the Mulefat Thickets portions of DG-3A were noted as showing varied levels of stress, which is approximately the same percentage of container plants that were showing stress during the previous qualitative monitoring event. Formal mortality counts were taken for DG-3A during the 2020 quantitative monitoring and were included in the 2020 annual reporting. The types of stress the plants were exhibiting are the same as those described for the plants in DG-2A. However, erosion is also a problem in some areas of DG-3A. Some of the planting basins were observed to have varied levels of erosion and should be repaired. The willow and mulefat stakes were observed to be thriving in this mitigation area. During the monitoring visit, the planted coast live oak (*Quercus agrifolia*) acorns were inspected for survivorship and health. Approximately 20 germinated coast live oak acorns appear to still be present in DG-3A. The majority of the germinated acorns appear to be in good health. During the monitoring, it was noted that an existing coast live oak tree (Tree Tag #39) was experiencing severe branch failure for multiple branches. The cause of the branch failure was unclear and further investigation is being conducted. The installation of the plants in the DG-3A mitigation area appears to have been completed successfully. The current issues noted during the monitoring are not expected to have a negative effect on the continued growth of the plants in the mitigation area. Photos 11 through 15 in Attachment B document the mitigation area during the monitoring visit.

Native plant growth was noted throughout the DG-3A mitigation area, likely both from natural recruitment and from seeding. Native plants such as annual bursage, California sagebrush (*Artemisia californica*), mugwort, mulefat, Canada horseweed, California poppy (*Eschscholzia californica*), and stinging nettle were observed sprouting in the DG-3A mitigation area. Native cover for the DG-3A mitigation area was estimated to be approximately 70 percent in the mulefat thickets portion of the mitigation area and 50 percent in the coast live oak woodland portion (60 percent overall).

Nonnative weed cover in DG-3A was estimated at approximately 10 percent, which is approximately 5 percent more than the level of nonnative cover that was observed during the previous qualitative monitoring event. Nonnative species observed in DG-3A included wild oat, black mustard, flax-leaved horseweed (*Erigeron bonariensis*), red-stemmed filaree, and perennial pepperweed. All nonnative weeds were just starting to germinate and had not gone to flower or seed. In addition, evidence of recent weeding was observed in the DG-2B mitigation area.

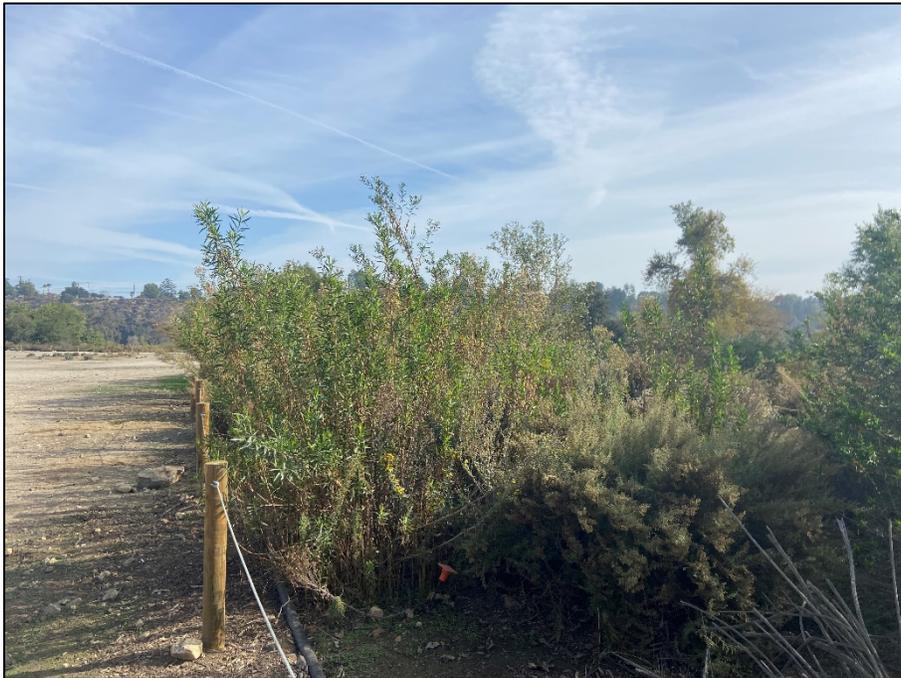
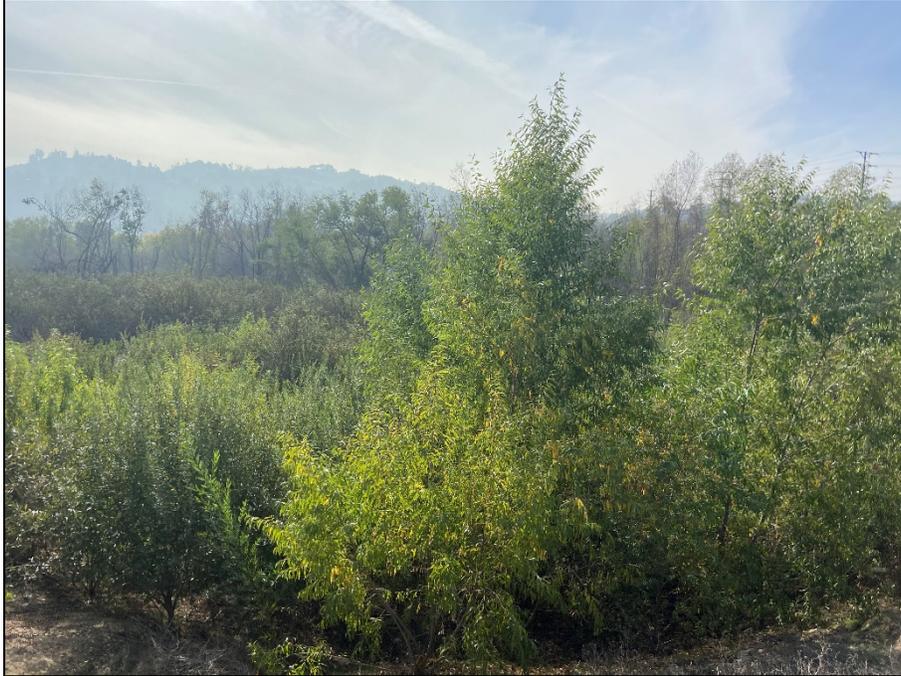
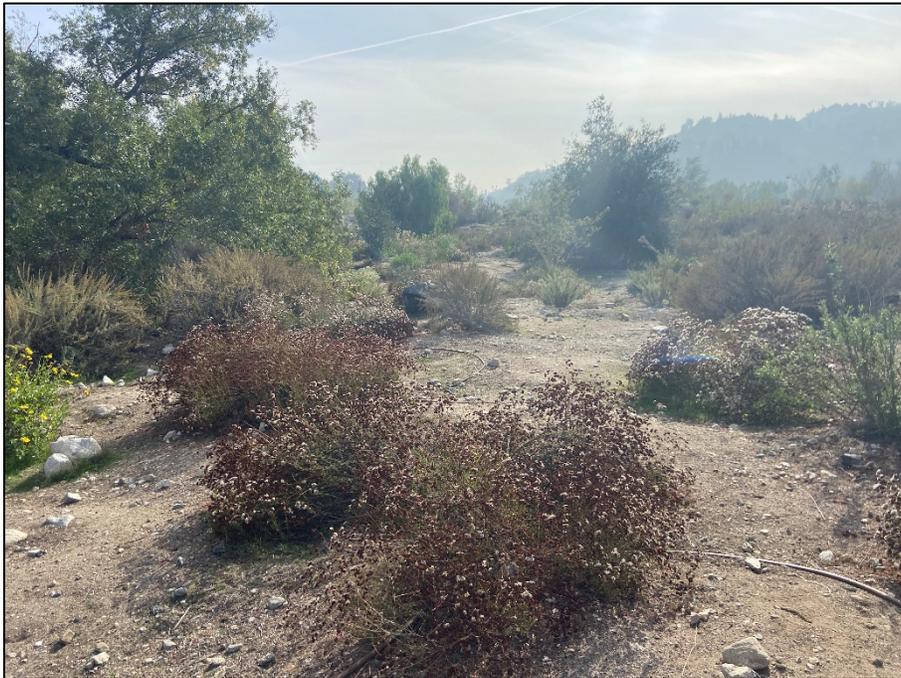
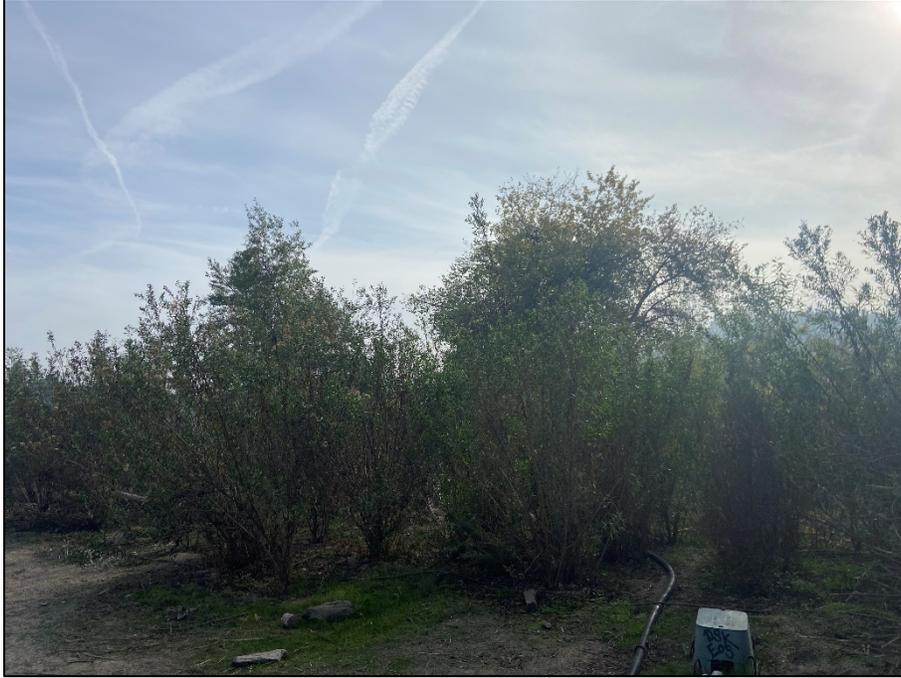
Photo 16: Overview Mitigation Area DG-4

The overall health of the container plants in mitigation area DG-4 was noted as being good. Approximately five percent of container plants in the coastal sage scrub portions of DG-4 were showing varied levels of stress which is approximately the same percentage of plants showing stress during the previous qualitative monitoring event. Approximately five percent of container plants in the riparian portions of DG-4 were showing varied levels of stress, which is approximately five percent less than the percentage of plants showing stress during the previous qualitative monitoring event. The stress appears to be mostly due to the same reasons described in DG-2A. For most portions of DG-4, only a negligible number of container plants were noted as being missing or dead. Formal mortality counts were taken for DG-4 during the 2020 quantitative monitoring and were included in the 2020 annual reporting. The willow and mulefat stakes were observed to be thriving in this mitigation area. Some of the planting basins were observed to have minor erosion and should be repaired. The installation of plants in the DG-4 mitigation area appears to have been completed successfully and the issues noted during the monitoring are not expected to have an impact on the continued growth of the plants. Photos 16 through 19 in Attachment B document the mitigation area during the monitoring visit.

Native plant growth was noted throughout the DG-4 mitigation area, likely both from natural recruitment and from seeding. Native plants such as mugwort, mulefat, California poppy, telegraph weed, Canada horseweed, California buckwheat (*Eriogonum fasciculatum*), salt heliotrope (*Heliotropium curassavicum*), caterpillar phacelia, and stinging nettle were observed sprouting in the DG-4 mitigation area. Native cover for the DG-4 mitigation area was estimated to be approximately 65 to 75 percent in the riparian portion of the mitigation area and 50 to 55 percent in the coastal sage scrub portion.

Nonnative weed cover in DG-4 was estimated at approximately 10 percent for most areas, which is approximately the same percentage of nonnative cover that was observed during the previous qualitative monitoring event. Nonnative species observed in DG-4 included black mustard, poison hemlock, perennial pepperweed, and white horehound (*Marrubium vulgare*). Nonnative weed cover, especially perennial pepperweed, is a significant problem in portions of the DG-4 mitigation area. Because perennial pepperweed can produce dense colonies through seed germination and underground rhizomes (rhizomatous roots), removal of this species without the use of systemic herbicide is very difficult. All nonnative weeds were just starting to germinate and had not gone to flower or seed. In addition, evidence of recent weeding was observed in the DG-2B mitigation area.

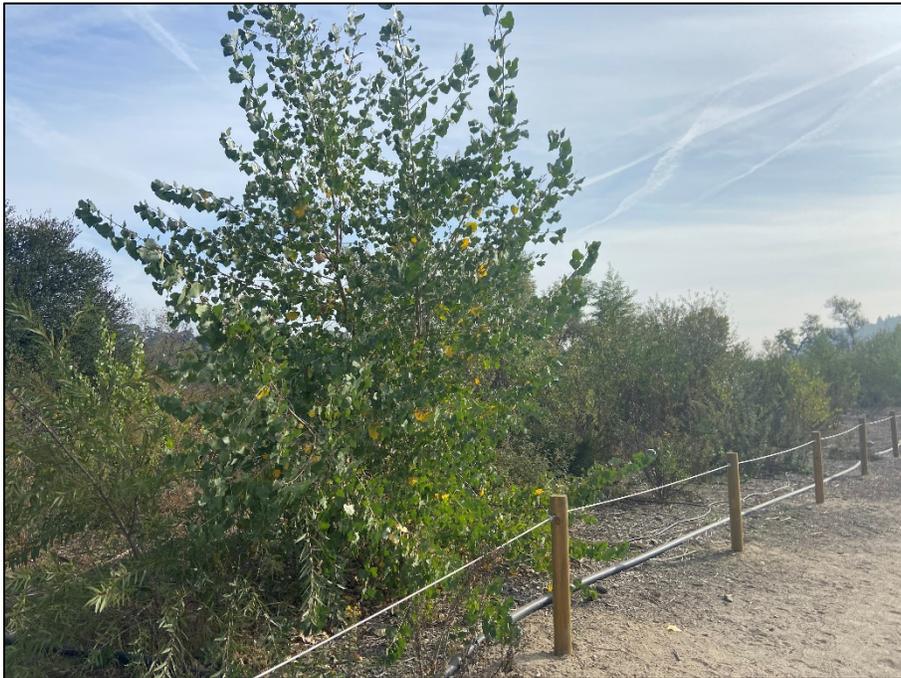
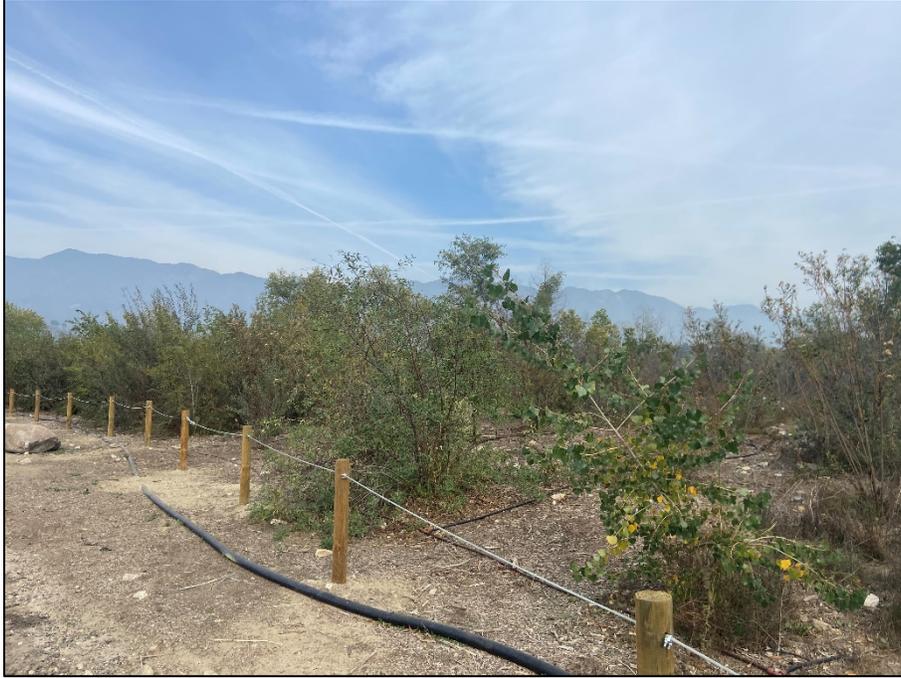
Photo 20: Overview Mitigation Area DG-4B

The overall health of the container plants in mitigation area DG-4B was noted as being good and this mitigation area is becoming well established. Approximately less than five percent of container plants were showing stress which is approximately the same percent of plants that were stressed during the previous qualitative monitoring event. The types of stress the plants were exhibiting are the same as those described for the plants in DG-2A. A negligible number of container plants were noted as being missing or dead. Formal mortality counts were taken for DG-4B during the 2020 quantitative monitoring and were included in the 2020 annual reporting. Some of the planting basins were observed to have minor erosion and should be repaired. The installation of plants in the DG-4B mitigation area appears to have been completed successfully and the issues noted during the monitoring are not expected to have an impact on the continued growth of the plants. Photos 20 and 21 in Attachment B document the mitigation area during the monitoring visit.

Native plant growth was noted throughout the DG-4B mitigation area, likely both from natural recruitment and from seeding. Native plants such as mugwort, tarragon (*Artemisia dracunculus*), mulefat, caterpillar phacelia, and stinging nettle were observed sprouting in the DG-4B mitigation area. Native cover for the DG-4B mitigation area was estimated to be approximately 70 to 75 percent.

Nonnative weed cover in DG-4B was estimated to be approximately less than five percent, which is approximately the same percentage of nonnative cover that was observed during the previous qualitative monitoring event. Nonnative species observed in DG-4B included black mustard, poison hemlock, and perennial pepperweed. All nonnative weeds were just starting to germinate and had not gone to flower or seed.

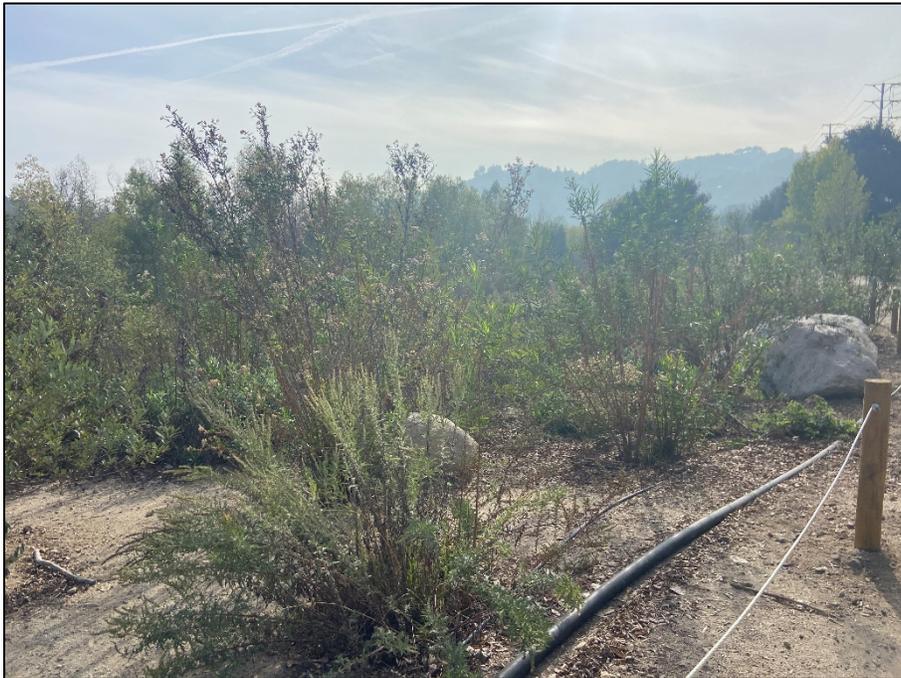
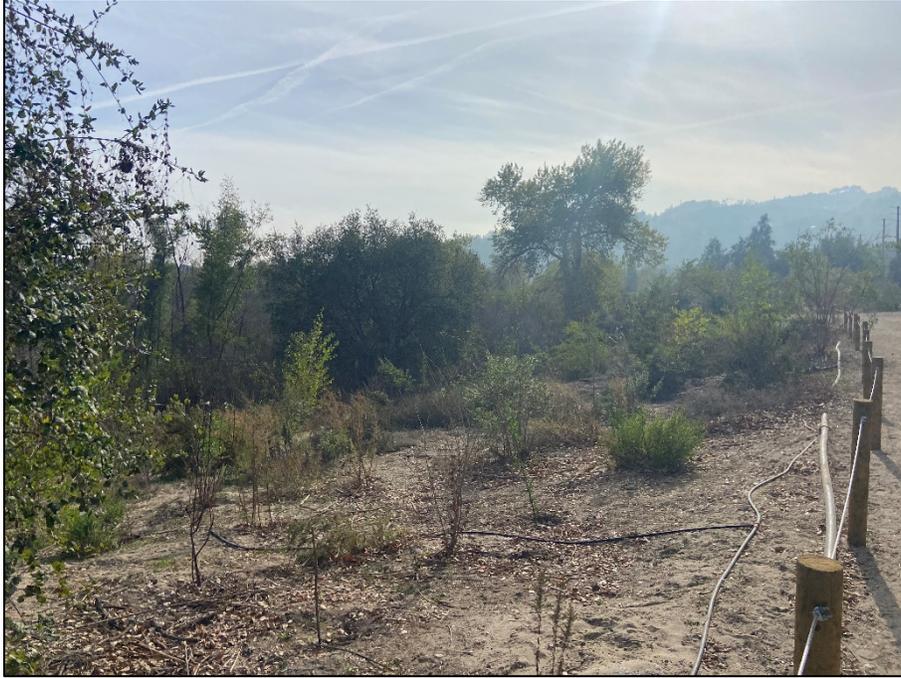
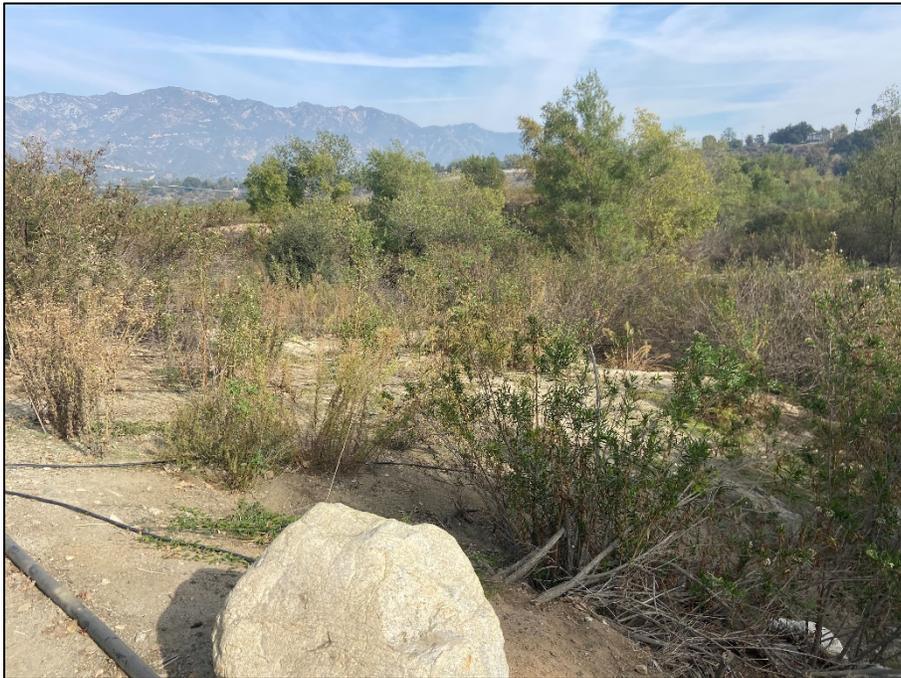
Photo 22: Overview Mitigation Area DG-4C

The overall health of the container plants in mitigation area DG-4C was noted as being good. Approximately five percent of all container plants were noted as showing minor levels of stress, which is approximately five percent less than percentage of plants that were showing stress during the previous qualitative monitoring event. The types of stress the plants were exhibiting are the same as those described for the plants in DG-2A. A negligible number of container plants were noted as being missing or dead. Formal mortality counts were taken for DG-4C during the 2020 quantitative monitoring and were included in the 2020 annual reporting. Some of the planting basins were observed to have minor erosion and should be repaired. The installation of plants in the DG-4C mitigation area appears to have been completed successfully and the issues noted during the monitoring are not expected to have an impact on the continued growth of the plants. Photos 22 to 24 in Attachment B document the mitigation area during the monitoring visit.

Native plant growth was noted throughout the DG-4C mitigation area, likely both from natural recruitment and from seeding. Native plants such as Canada horseweed, telegraph weed, and caterpillar phacelia were observed sprouting in the DG-4C mitigation area. Native cover for the DG-4C mitigation area was estimated to be approximately 55 percent.

Nonnative weed cover in DG-4C was estimated at approximately less than five percent, which is approximately the same as the level of nonnative cover that was observed during the previous qualitative monitoring event. Nonnative species observed in DG-4C included black mustard, poison hemlock, and perennial pepperweed. All nonnative weeds were just starting to germinate and had not gone to flower or seed

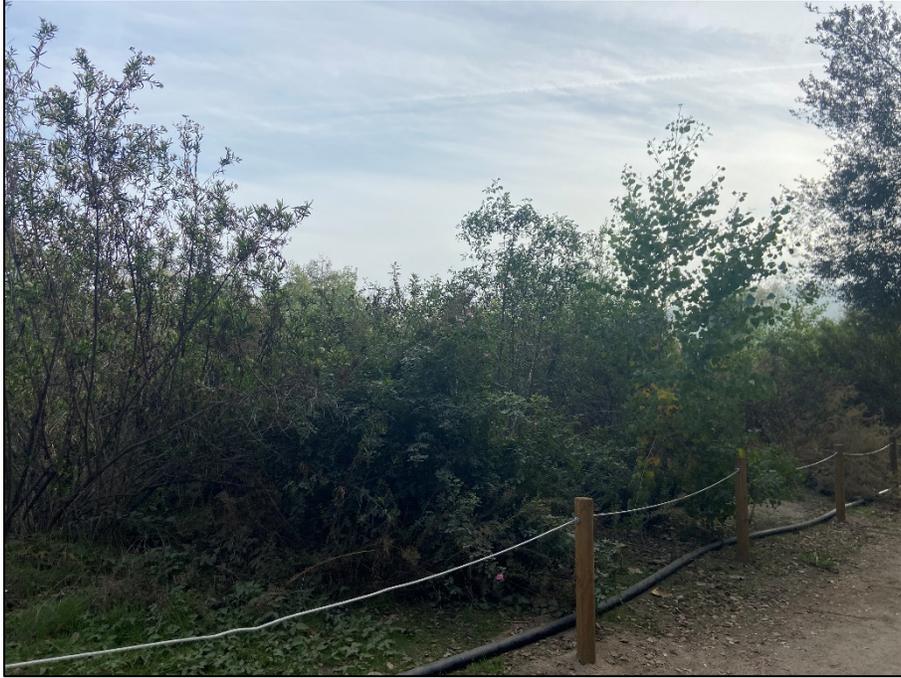
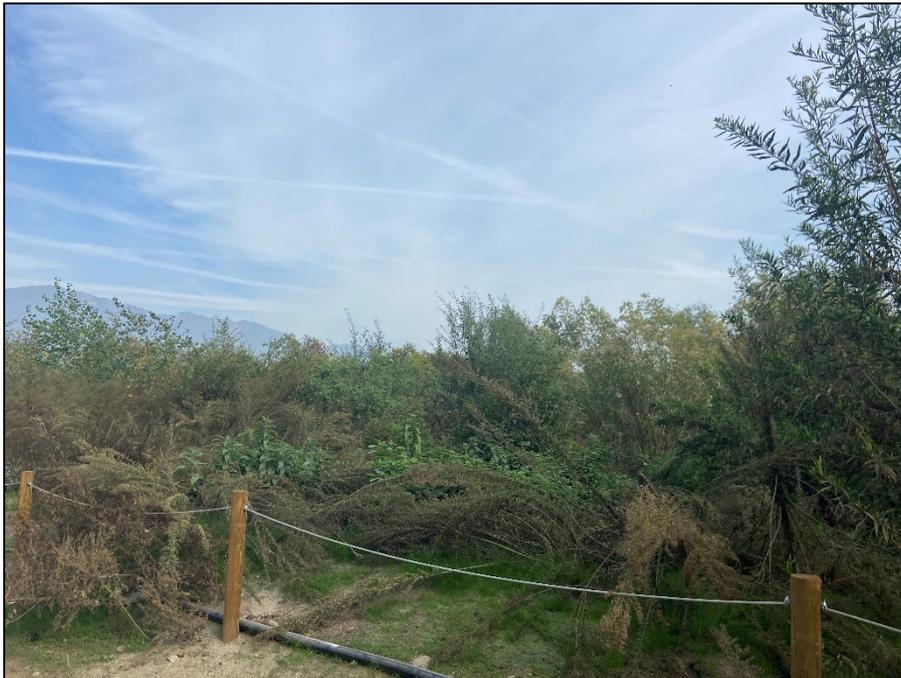
Photo 25: Overview Mitigation Area DG-5

The overall health of the container plants in the DG-5 mitigation area was noted as being good. Approximately less than five percent of all container plants were noted as showing varied levels of stress, which is approximately the same as the percentage of plants that were showing stress during the previous qualitative monitoring event. Formal mortality counts were taken for DG-5 during the 2020 quantitative monitoring and were included in the 2020 annual reporting. Some of the planting basins were observed to have minor erosion and should be repaired. The installation of plants in the DG-5 mitigation area appears to have been completed successfully and the issues noted during the monitoring are not expected to have a negative impact on the continued growth of the plants. Photos 25 and 26 in Attachment B document the mitigation area during the monitoring visit.

Native plant growth was noted throughout the DG-5 mitigation area, likely both from natural recruitment and from seeding. Native plants such as mugwort, mulefat, Canada horseweed, caterpillar phacelia, and stinging nettle were observed sprouting in the DG-5 mitigation area. Native cover for the DG-5 mitigation area was estimated to be approximately 75 to 80 percent and the site is thriving.

Nonnative weed cover in DG-5 was estimated at approximately less than five percent, which is approximately the same percentage of nonnative weed cover that was observed during the previous qualitative monitoring event. Nonnative species observed in DG-5 included black mustard, poison hemlock, and perennial pepperweed. All nonnative weeds were just starting to germinate and had not gone to flower or seed
