Memorandum

Subject: Results of Soil Sample Analysis for the Devil's Gate Reservoir Restoration Project

ATTACHMENT 1 – SAMPLING LOCATIONS (FIGURE 1)

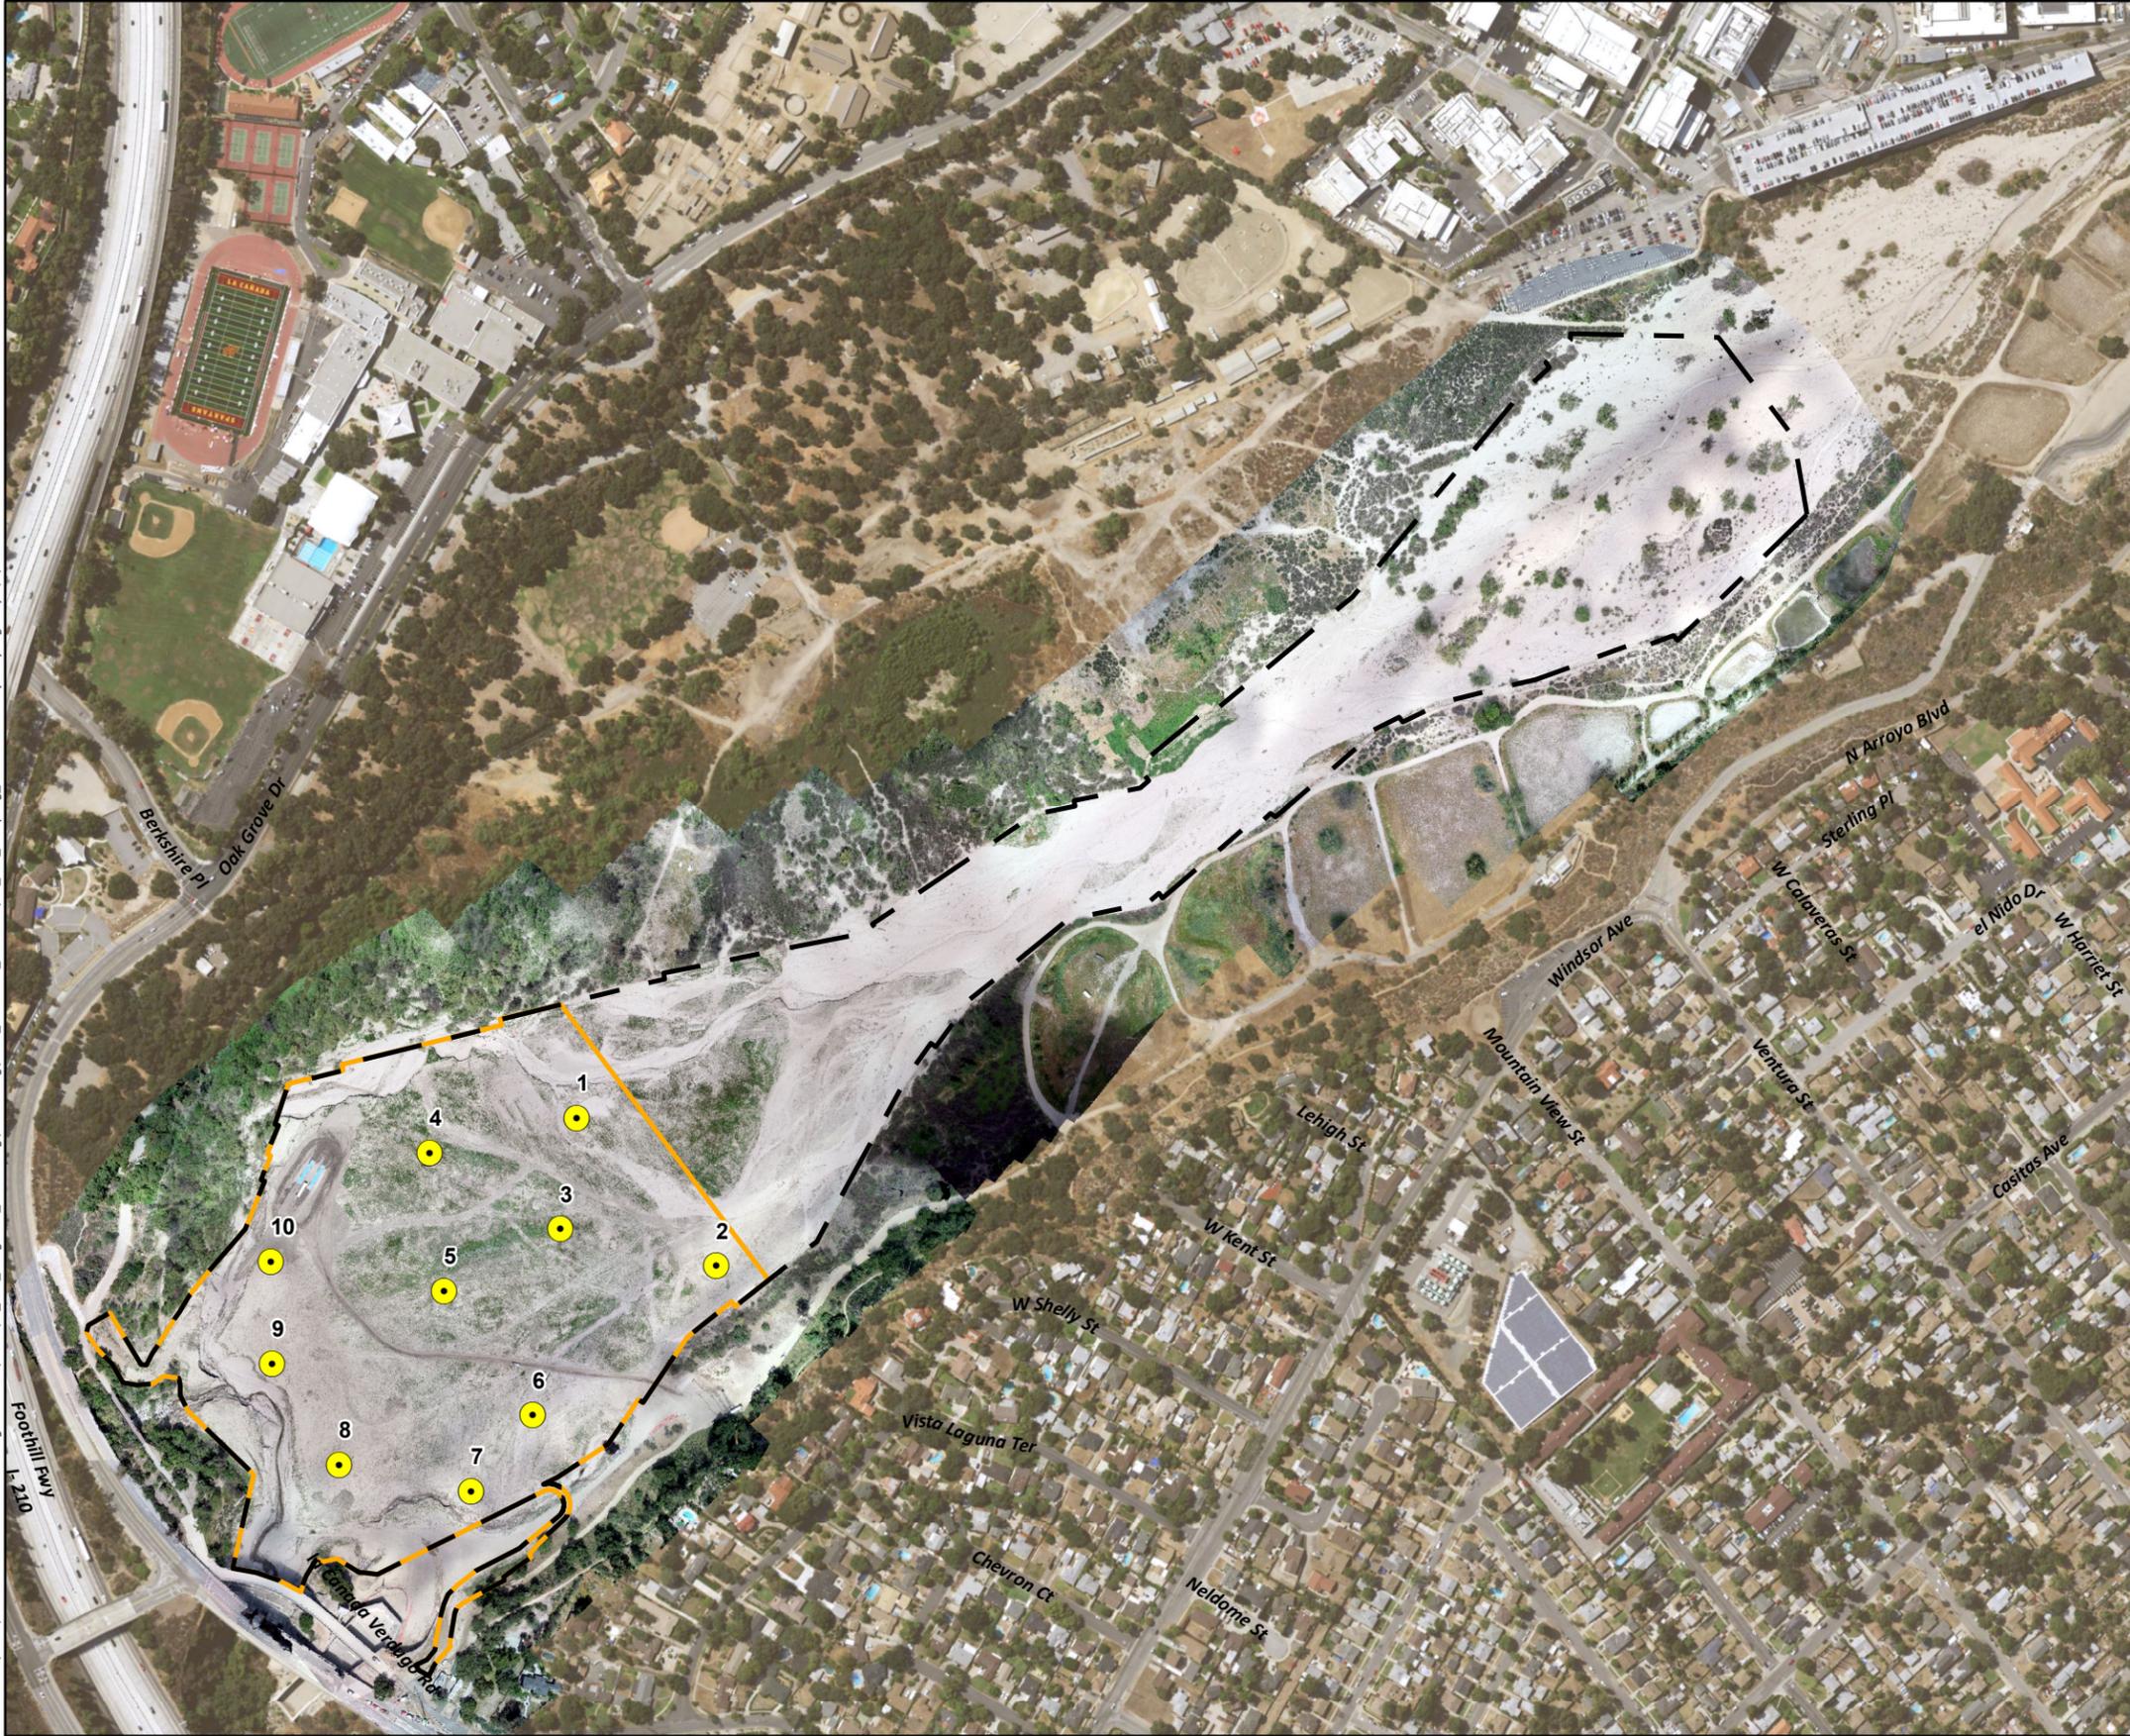
Figure 1
Soil Sample Locations

To get a broad range of samples from the area where sediment will be removed during the first year of the Project, ten sampling locations were systematically selected within the approximately 25-acre area (first year removal area) identified by LACPW (Figure 1 in Attachment 1). The locations were programmed into the ESRI Collector Classic App on an iPhone prior to conducting the sampling to ensure the samples were taken from the selected locations. Sampling locations were purposefully not selected in areas where sediment had been manipulated by heavy equipment or removed for the purpose of building access roads.
