Devil's Gate Monitoring Log

Devil's Gate Reservoir Restoration Project - 2018-047.009

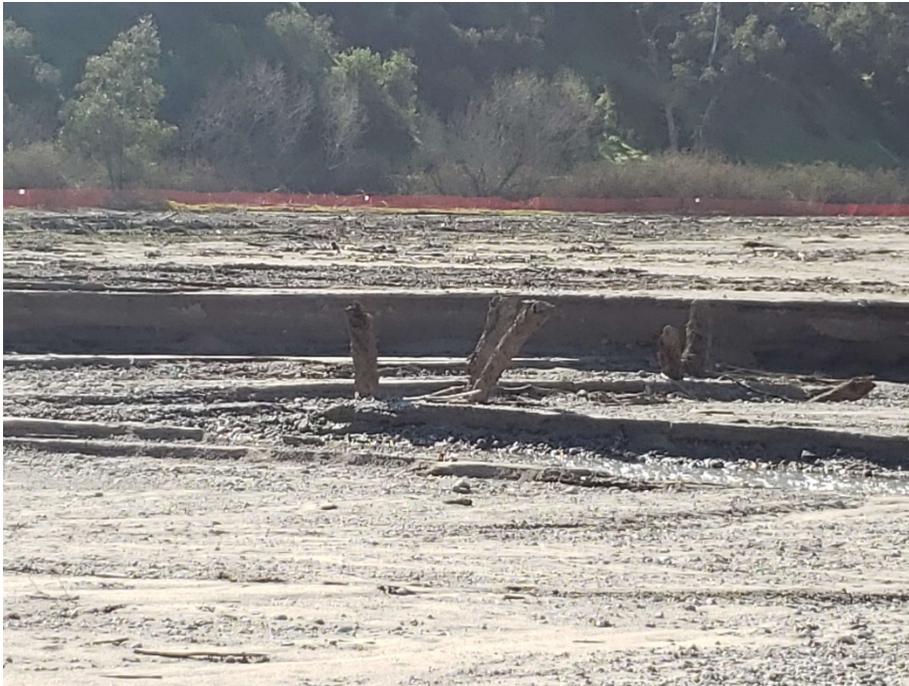
Log Entry #3 Photo A

0845- 0909 Observed CSJA-1. 0902 Observed 1 CSJA fly from nest location in top southeast quadrant of oak tree. 0904 one CSJA flew from nest location to perch in adjacent tall nonnative tree while another CSJA flew into nest tree. Joggers and walkers, most with off leash dogs passed within 5 feet of nest tree. Nest appears to still be nest building.

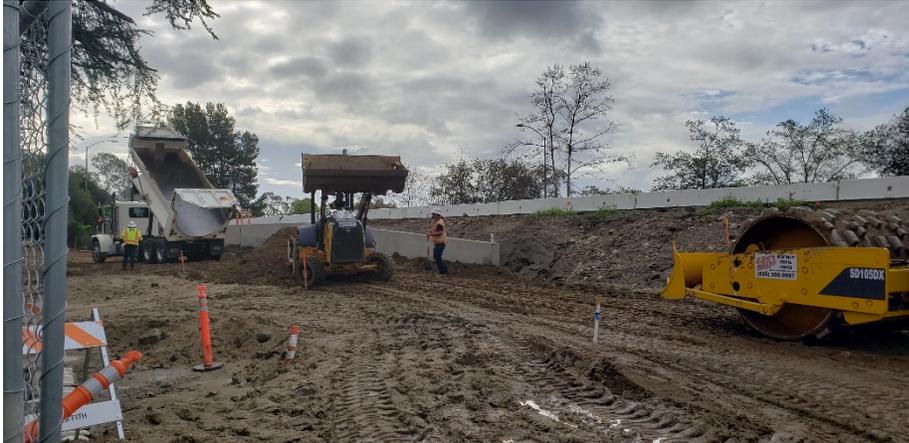
Log Entry #4 Photo A

0855-0928 Observed work in the eastern access road area. No ANHU detected in vicinity and no activity at ANHU-1. Observed BLPH foraging in work area while construction activities were ongoing and make 2 trips with mud to BLPH-1.

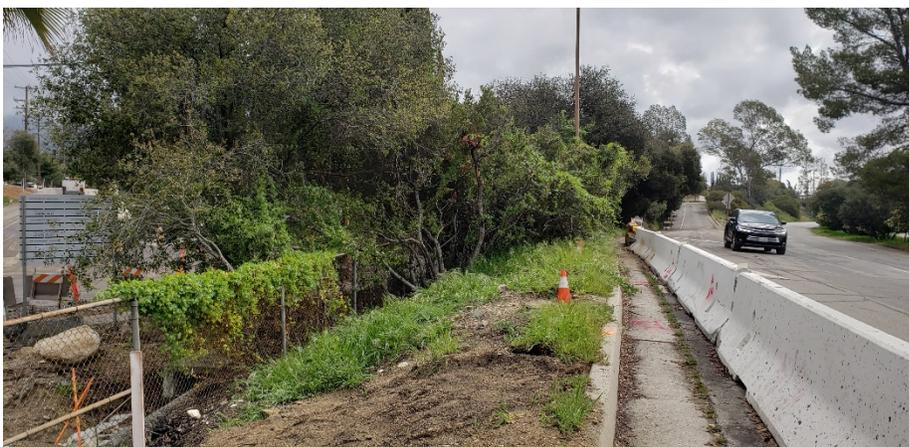
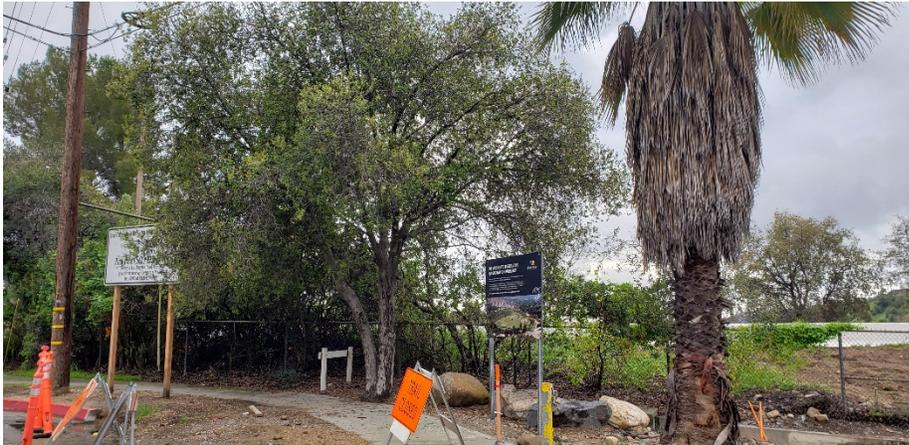
Log Entry #5 Photo A

1013-1044 Joe asked if an area between the eastern access road and Oak Grove Dr. could be checked as they plan to clear it tomorrow or Monday. Area only contained newly sprouted low cover vegetation that was almost entirely nonnative. Adjacent to oak tree #21 but it was anticipated to be partially impacted in the Tree Report. Joe said they would not be removing any of the adjacent native vegetation. No nests or nesting birds detected in the area immediately adjacent however a BLPH continued to collect mud inside the work area as construction activities continued. Photos looking east, and then south (of oak tree #21).

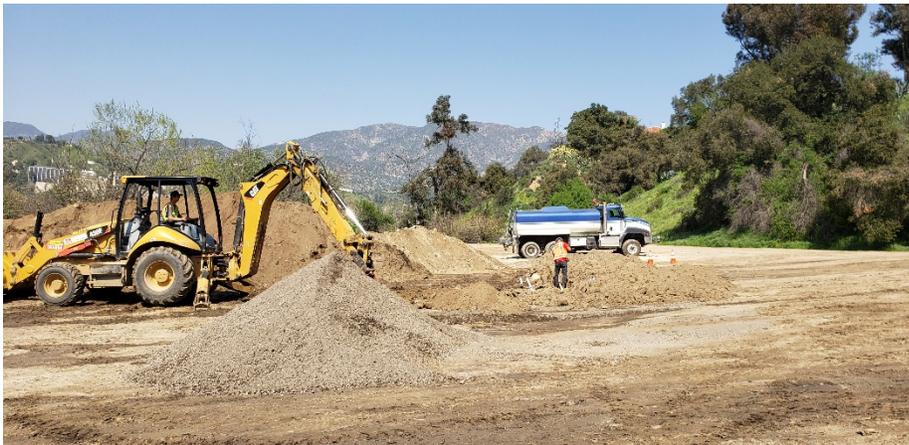
Log Entry #7 Photo A

1412 construction activity at staging area is still occurring. Backhoe loader and 1 crew member working on trench. 1428 ANHU-3 Female still incubating while construction occurring within 115 feet of nest.
